Airworthiness Directive Schedule

Aeroplanes

Piper PA-31 Series (Navajo, Chieftain, Mojave, Cheyenne and T1040)

29 July 2021

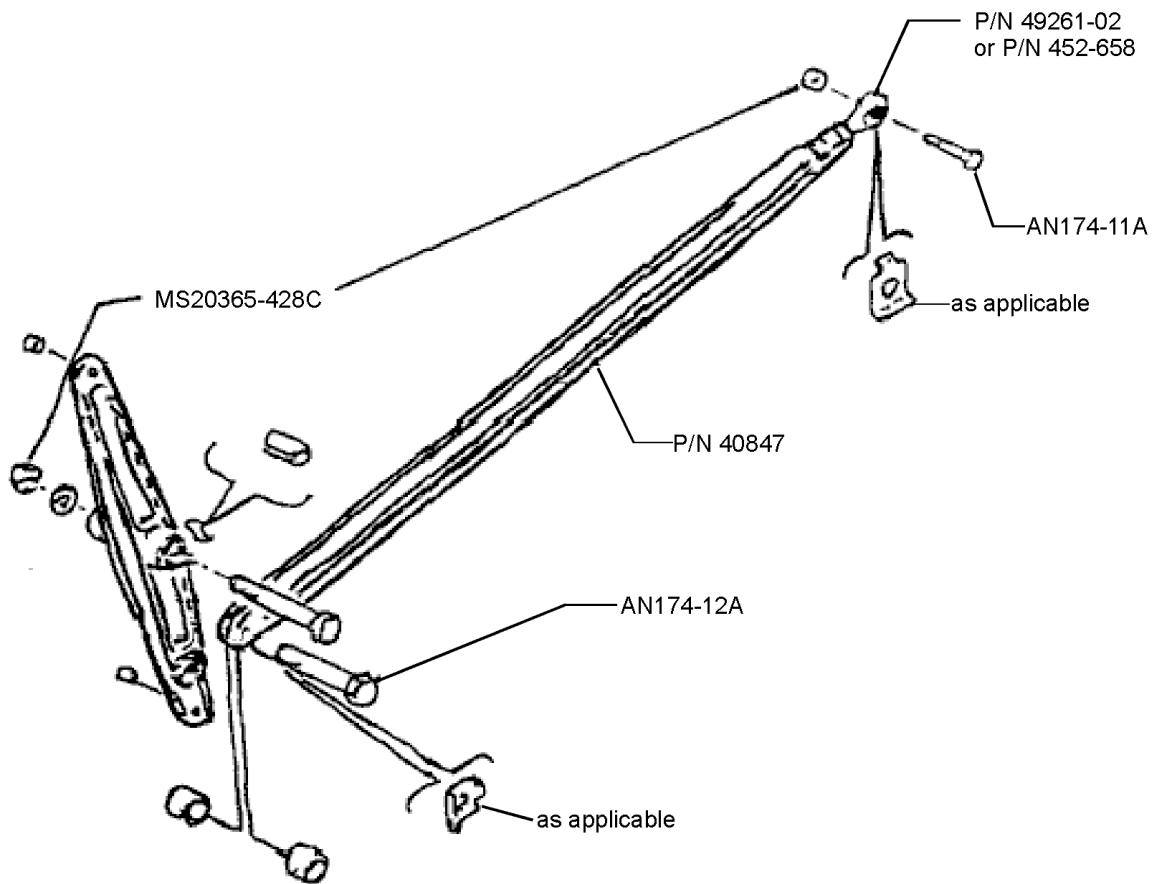
Ensure that the elevator control tube assembly area is not damaged by accomplishing the following inspections and procedures:

3. Secure the aft end of the bungee link to the elevator horn with safety wire for removal and installation of the bungee attach bolt.
4. Inspect, using FAA-approved magnetic procedures, the rod end shank and threads for cracks. If found cracked, prior to further flight, replace the rod end with part number (P/N) 49261-02 or P/N 452-658.

5. Visually inspect the bearing in the rod end for wear and free movement. IF wear is found or the bearing will not move, prior to further flight, replace the rod end with P/N 49261-02 or P/N 452-658.

6. Inspect, using a 10X magnifying glass, the forward attach holes in the pushrod for cracks, corrosion, or elongation. If cracks, corrosion, or elongation is found, prior to further flight, replace the pushrod with P/N 40847-00, 40847-04, or 40847-07, as applicable.

7. Visually inspect the forward and aft attach area to ensure that both a forward bolt, P/N 402 311 (AN 174-12A), and an aft bolt, P/N 402 317 (AN 174-11A), are installed. If either one of these bolts is not installed, prior to further flight, install the applicable bolt or replace the existing bolt with one of the applicable part number.

Note 1: Figure 1 of this AD illustrates the elevator assembly and the specific areas that are to be inspected.
