# Airworthiness Directive Schedule

### Beechcraft 58 and 95 Series (Baron)

29 August 2013

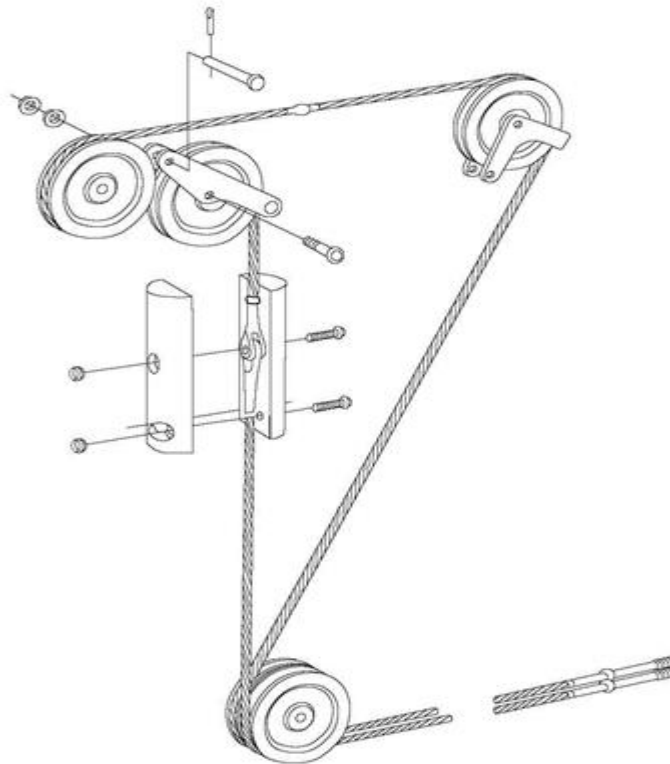
Figure 1 - Forward Elevator Control Cable - Adapted from the Beechcraft IPC.

**Note 1:** No further AD action required for those aircraft already in compliance with DCA/B55/46. This AD revised to clarify the applicability and revise the requirement. Figure 1 introduced to provide additional information to determine AD applicability. The repetitive inspections and the requirement to replace forward elevator control cable assemblies which have been in service for more than 15 years has been removed from this AD with the publication of manufacturer Instructions for Continuing Airworthiness (ICA).

Inspect the forward elevator control cable assembly for wear, broken wires and corrosion. If any defects are found, replace the forward elevator control cable assembly before further flight.

1. Replace the forward elevator cable assembly, or

2. Cable assemblies or parts removed from service per the requirements of this AD may not be installed on any aircraft.
