Airworthiness Directive Schedule

Engines

Honeywell International LTS101 and T53 Series

30 June 2022

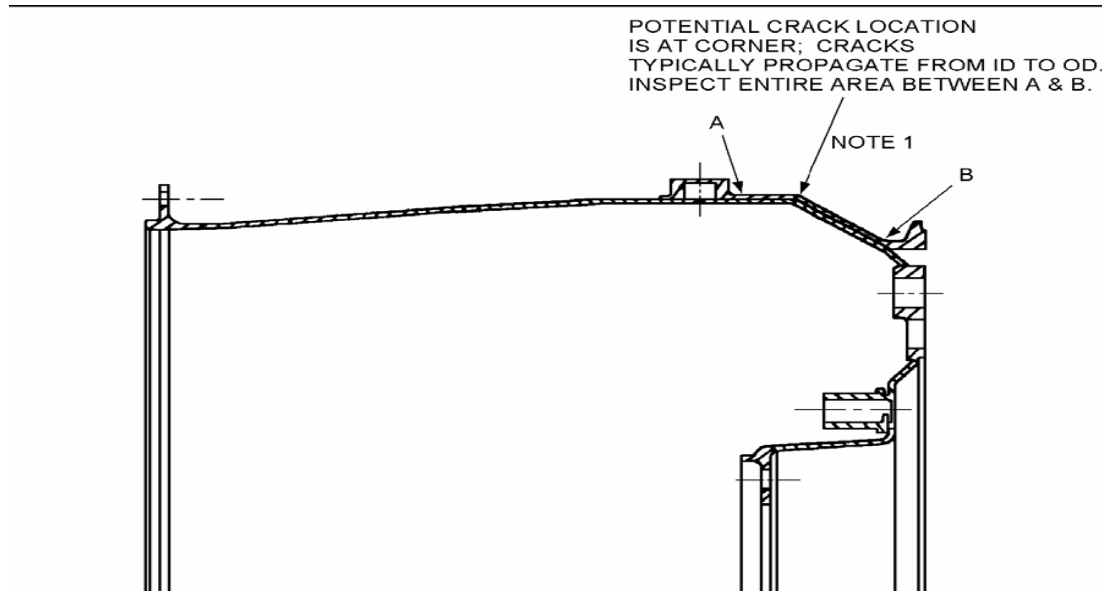
Figure 1: Visual Inspection of Combustion Chamber Housing (CCH)

Inspect the area between points A and B around the entire housing circumference in figure 1 of this AD for weld repairs and cracks.

Note 1: No weld repairs allowed in this area.

If any cracks are found, replace the CCH per Honeywell International ASB T53-A0142 revision 1, dated 14 September 2006 before further flight.

If any weld repairs are found replace the CCH within the next 100 hours TIS after accomplishing the visual inspection per requirement 1 of this AD.
