Airworthiness Directive Schedule

Lycoming LTIO-540 and TIO-540 Series Engines

28 February 2019

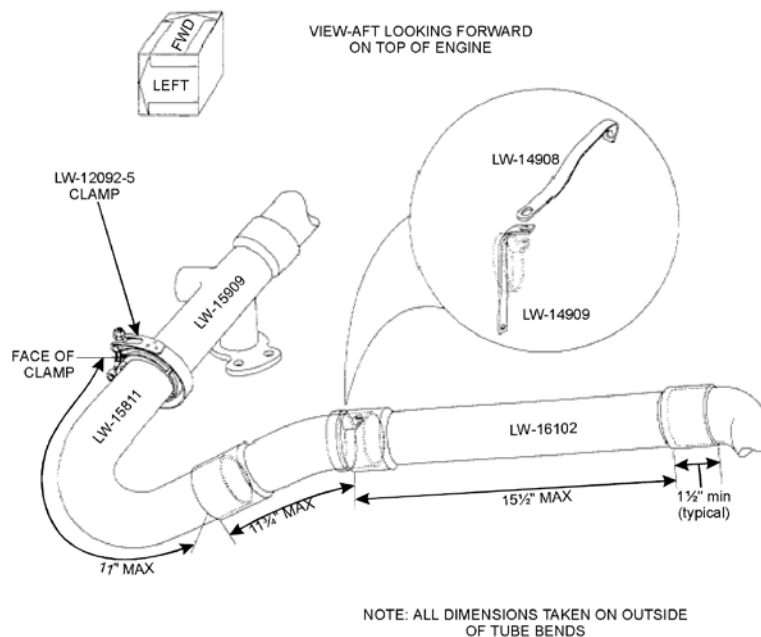
Requirement: To prevent exhaust system leaks which may cause engine failure or fire, accomplish the following:

1. Inspect all exhaust system joints, flanges, couplings and brackets for heat damage, distortion, cracks or excessive wear per Textron Lycoming SB 484. Inspect the exhaust system for proper slip joint engagement by measuring distances between pipe end points of LW-16102 (RH) and LW-16103 (LH) per the diagram. If damage is found in the exhaust system or measurements which exceed allowable dimensions, repair or replace damaged parts with serviceable parts as necessary, before further flight.

2. Install new design one-piece exhaust riser kit (05K21503) and manifold retainer kit (05K19650-S) per SB 499C.
