Airworthiness Directive Schedule

Engines

Rolls-Royce 250 Series Turbine Engines

26 May 2022

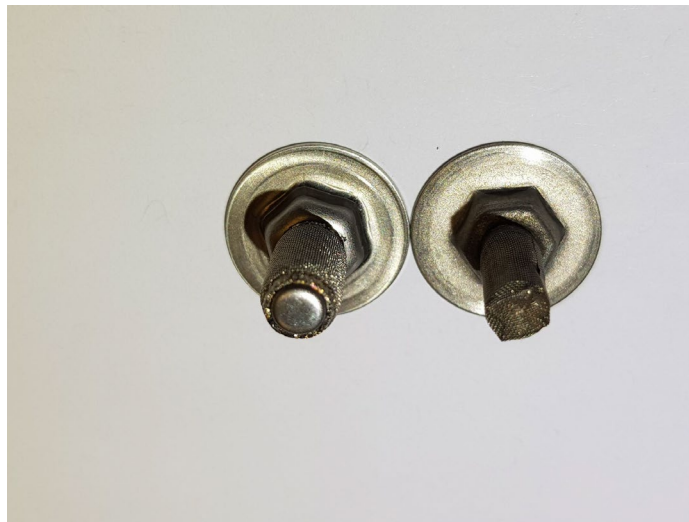
Note: New design fuel nozzle assemblies have a screen filter with a solid metal disc at the aft end of the screen filter. New design fuel nozzles have a screen filter with P/N 139968.

The screen filter on the left of the photo is the new design screen filter, which has a solid metal disc at the aft end of the screen filter.

The screen filter on the right of the photo is the old design screen filter, which is completely constructed of gauze mesh, including the aft end of the screen – Replace before further flight.

If the aft end of the screen filter is constructed of gauze mesh, then replace the fuel nozzle before further flight.

If the inspection through the fuel inlet of the nozzle assembly cannot determine that the aft end of the screen filter has a solid metal disc, then replace the fuel nozzle before further flight.
