# Airworthiness Directive Schedule

## Helicopters

### Robinson R44 Series

29 February 2024

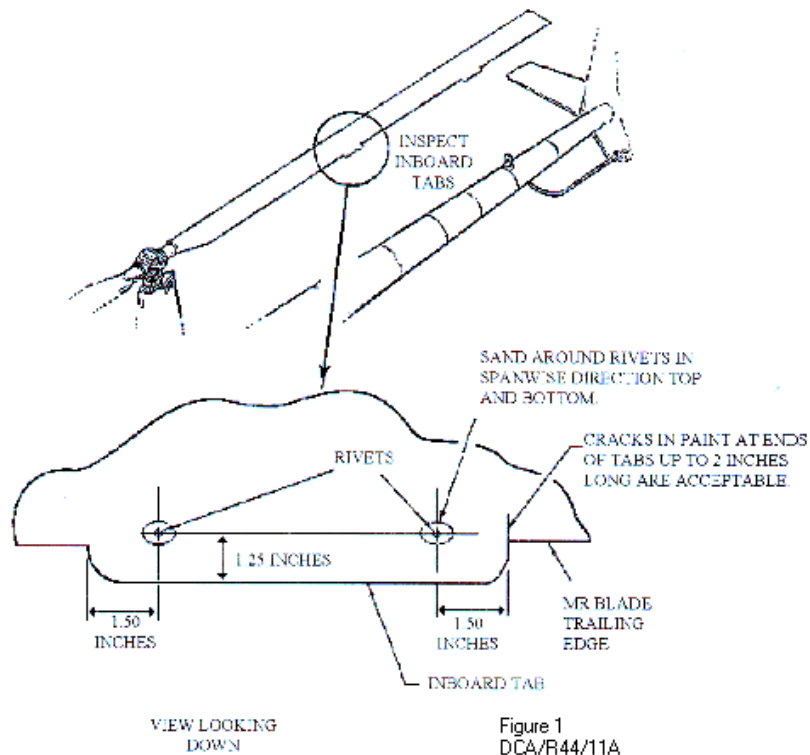
1. Perform a dye-penetrant inspection of the main rotor blade skin around both inboard trim tab alignment rivets as follows, referring to Figure 1.

b) Inspect the main rotor blade skin around the rivets on the upper and lower surfaces (4 locations) using a dye-penetrant inspection method.

**Note 1:** Chord-wise cracks in the paint up to 2 inches long which are located along either inboard or outboard edge of the trim tab are acceptable.

2. Using a 5-power or higher magnifying glass, visually inspect both upper and lower main rotor blade skin surfaces around the inboard trim tab rivets (4 locations) for cracks. If a crack is found, replace the main rotor blade with an airworthy main rotor blade before further flight.

3. Install a set of main rotor blades, P/N C016-2. This constitutes terminating action for the inspections required by this AD.
