**CIVIL AVIATION AUTHORITY
OF NEW ZEALAND**

**AIRCRAFT SERIOUS INCIDENT REPORT
OCCURRENCE NUMBER 00/2518
B767-319ER
ZK-NCJ**

**NZ 60
'ERRONEOUS' GLIDESLOPE CAPTURE,
AUTOCOUPLED APPROACH,
AND GO-AROUND**

**FALEOLO AIRPORT, SAMOA
29 JULY 2000**

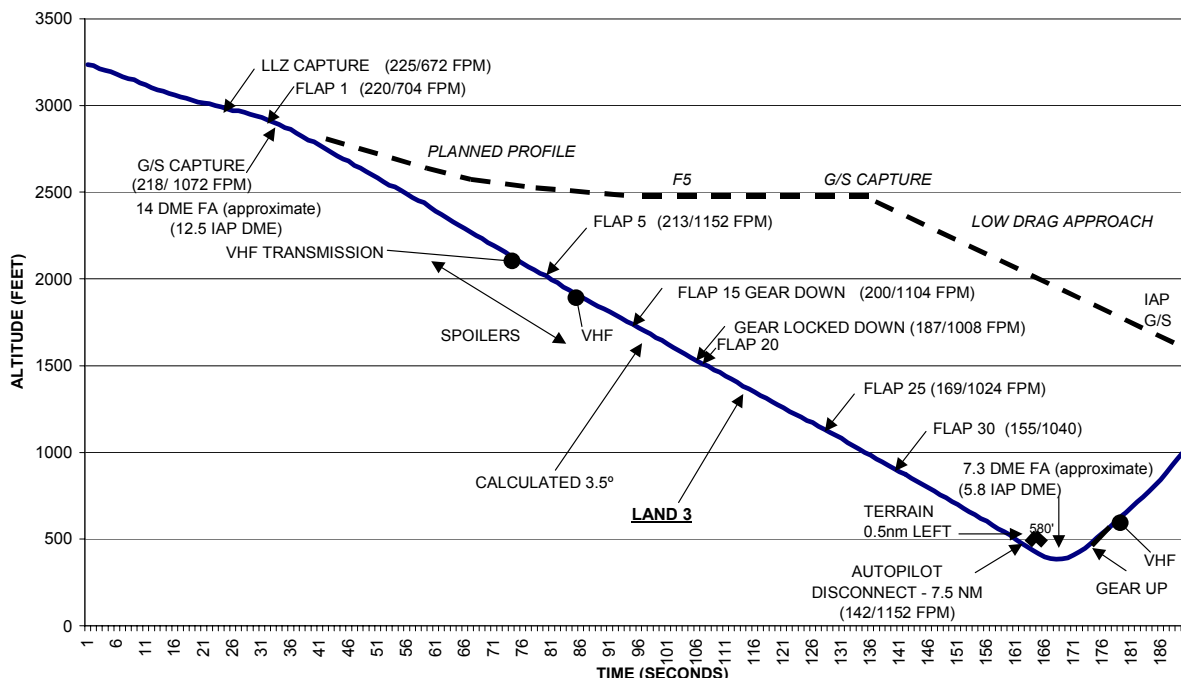
NZ 60 Profile - First Approach Apia

Analysis of the profile for the first approach revealed a subtle steepening of the approach angle from approximately 3.3°, at ‘glideslope’ capture, to 4.3° prior to the commencement of the missed approach. This would account for the steady rate-of-descent despite the reducing ground speed.

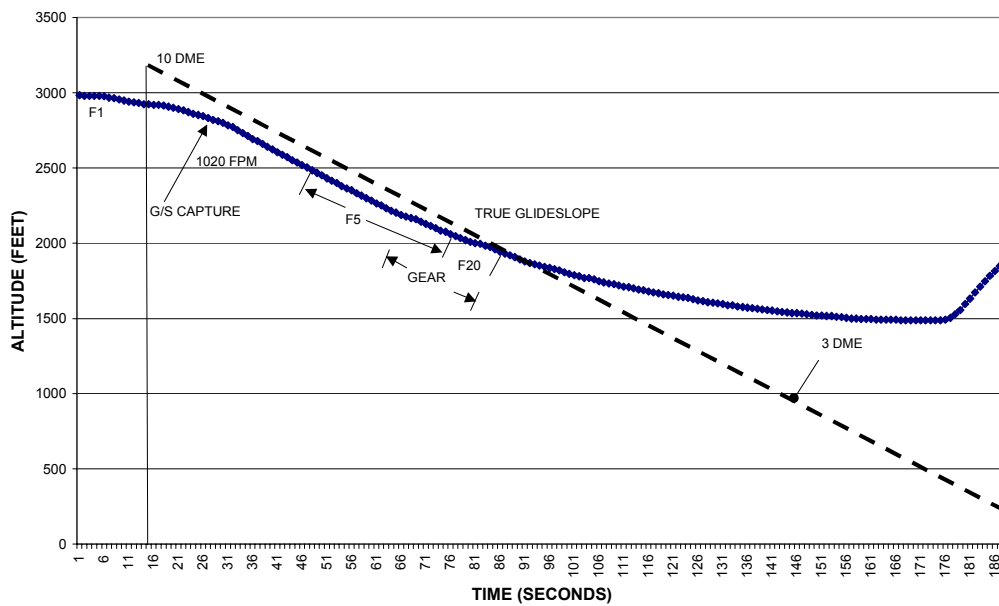
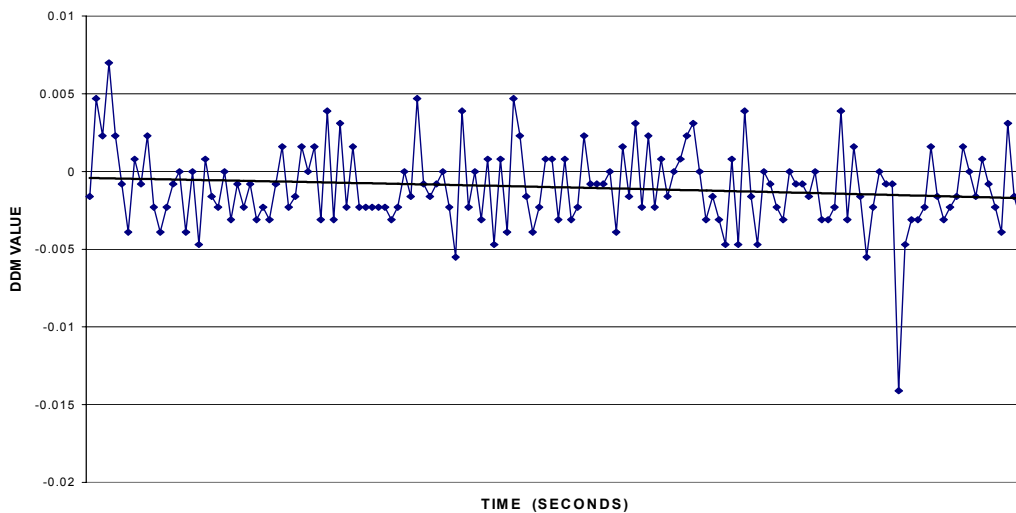
Proving Flight One – Profile One

The transition to glideslope capture occurred from the Vertical Speed mode with the left autopilot engaged in CMD. From glideslope capture the aircraft assumed a ROD of 1000 fpm which decreased throughout the profile to a point 7.8 track miles after glideslope capture where the aircraft was at 1480 ft altitude and in level flight.

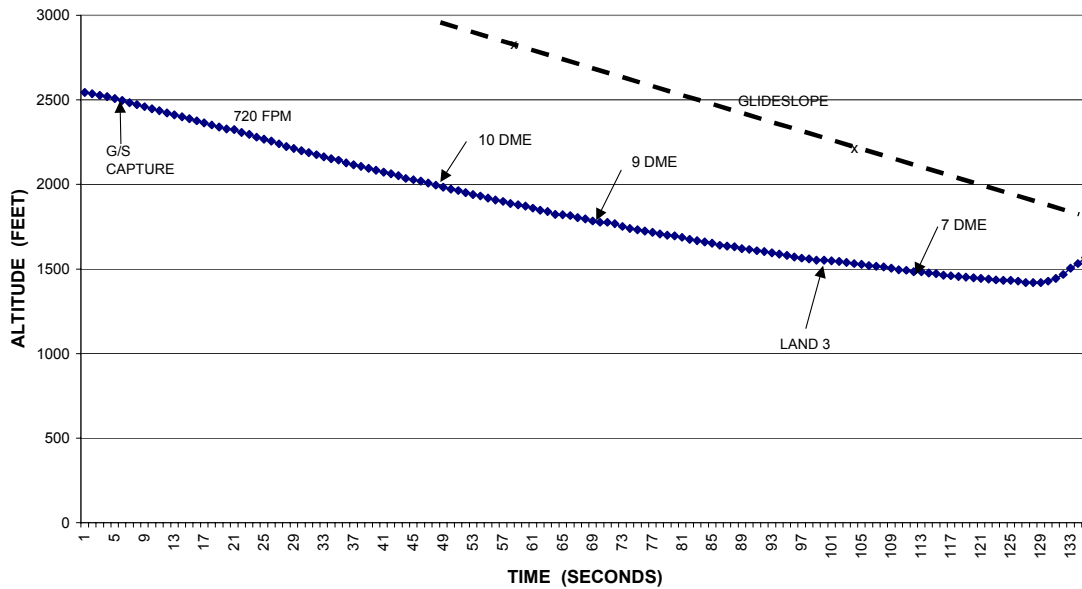
Proving Flight One – Profile Two

Glideslope capture occurred some 1000 ft below the actual glideslope. The aircraft remained on a ‘below glideslope’ profile, and ‘LAND 3’ was annunciated on the Autoland Status Annunciator panel at 1500 ft RA. The aircraft descended on a shallow profile, losing approximately 1100 ft in 5.5 track miles.

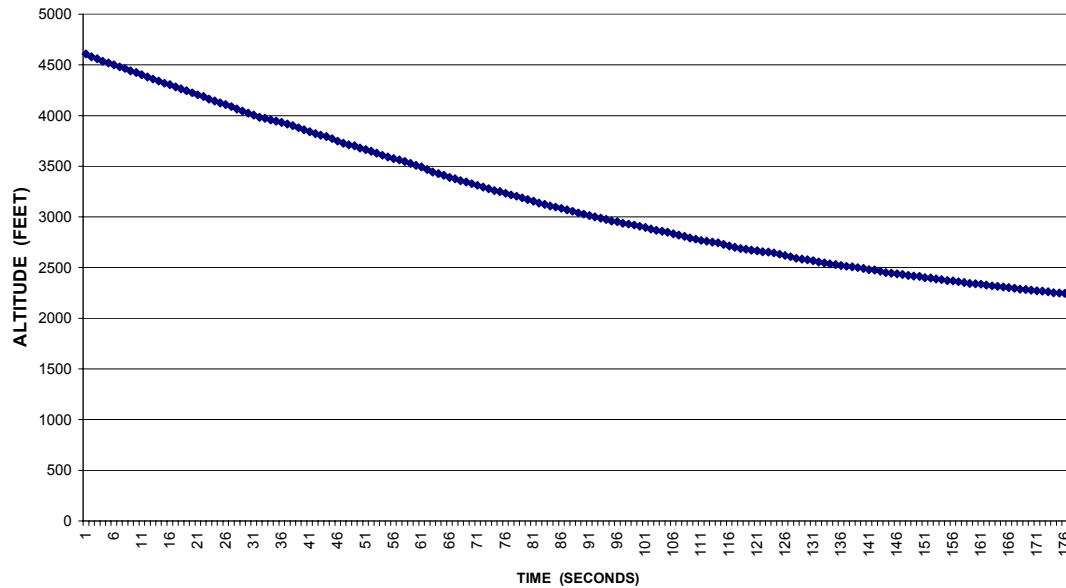
Proving Flight One – Profile Four

For the fourth approach the aircraft was positioned above the true glideslope in the Vertical Speed mode and with a ROD of 1500 fpm selected. At the glideslope capture point the ROD decreased to 1200 fpm. During descent the ROD slowly bled back to 1000 fpm until the go around point.

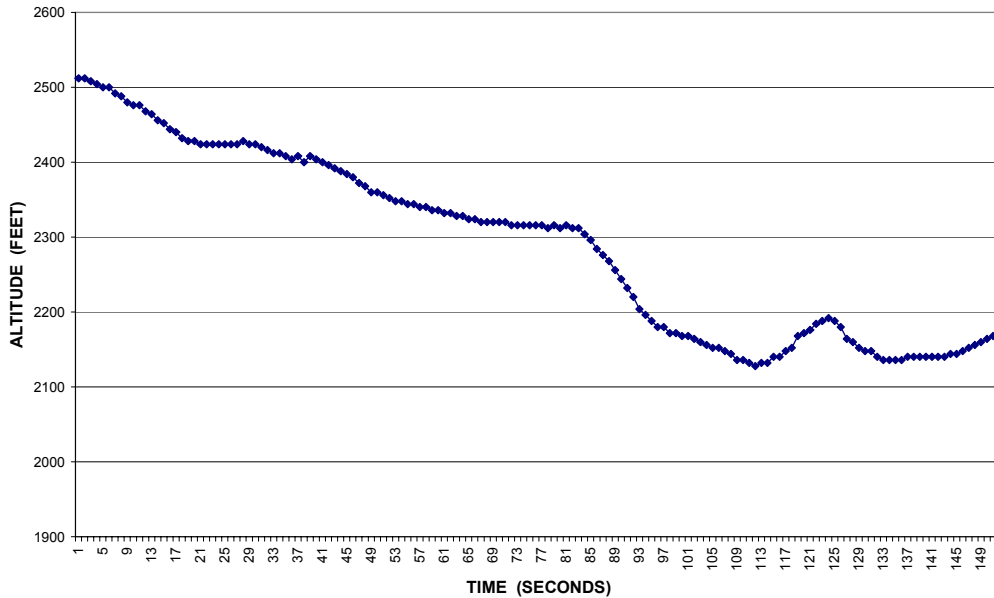
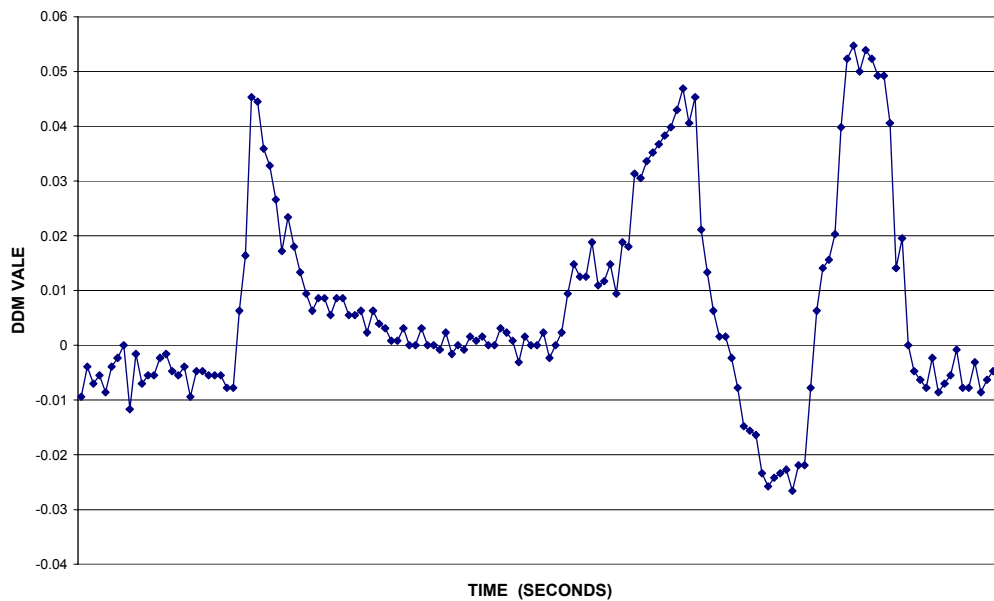
Proving Flight One – Profile Five

For the fifth approach the DDM value was varied from the ground to establish whether the residual DDM value could affect the aircraft flight path. Transition to glideslope capture occurred from Altitude Hold mode. Glideslope capture occurred with the aircraft in level flight at 160 knots and with the flaps at 20. Subsequent to glideslope capture there was no change in flap position and little change in airspeed or thrust setting. It was noted that varying the DDM value would vary the aircraft profile.

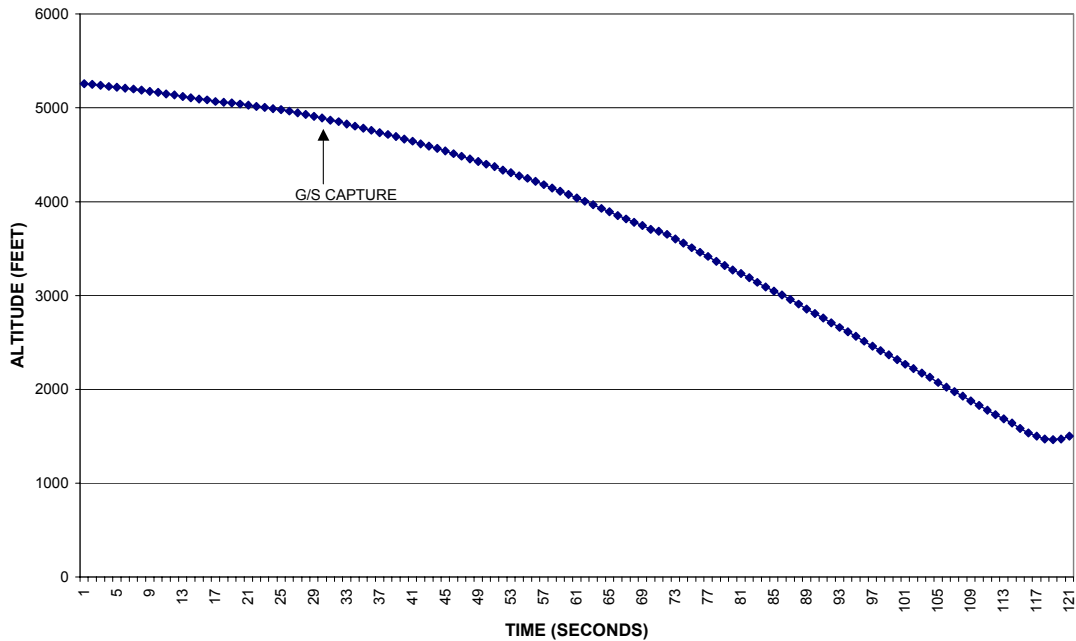
Proving Flight Two – Profile One

The automatics captured the ‘glideslope’ as expected. In apparent response to the fly down signal, the aircraft continuously pitched down on a steepening approach that commenced at approximately 3.5° and reached 8.5° toward the end. ROD increased throughout the approach from 1200 fpm to 3000 fpm. Despite the deployment of speedbrakes and extension of landing gear, the aircraft could not be slowed and configured for landing.

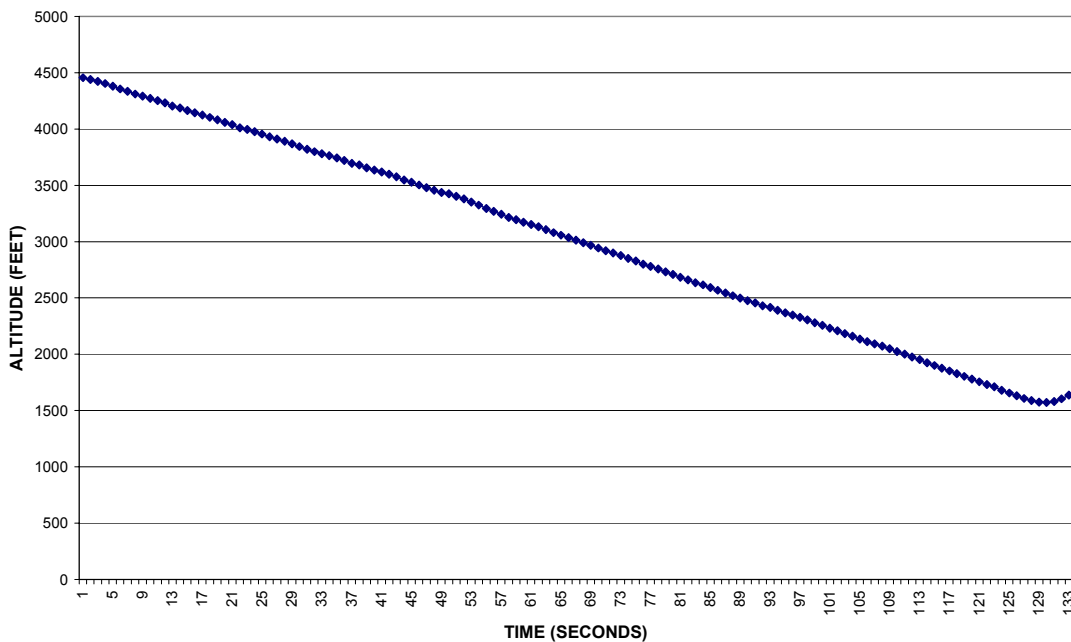
Proving Flight Two – Profile Two

Having verified the hypothesis with respect to the plus and minus DDM values, this profile was expected to closely replicate the profile encountered by the crew at Faleolo. This was achieved with a reasonably constant ROD of 1200 fpm. Speedbrakes were deployed and landing gear extended early to slow the aircraft, with landing configuration being reached some 2700 ft after glideslope capture. Analysis of the glideslope angle revealed an angle of 3° at glideslope capture increasing to over 6.5° at the bottom. The steeper angle of this approach was most likely attributable to the fly down signal being slightly greater than that encountered at Faleolo.

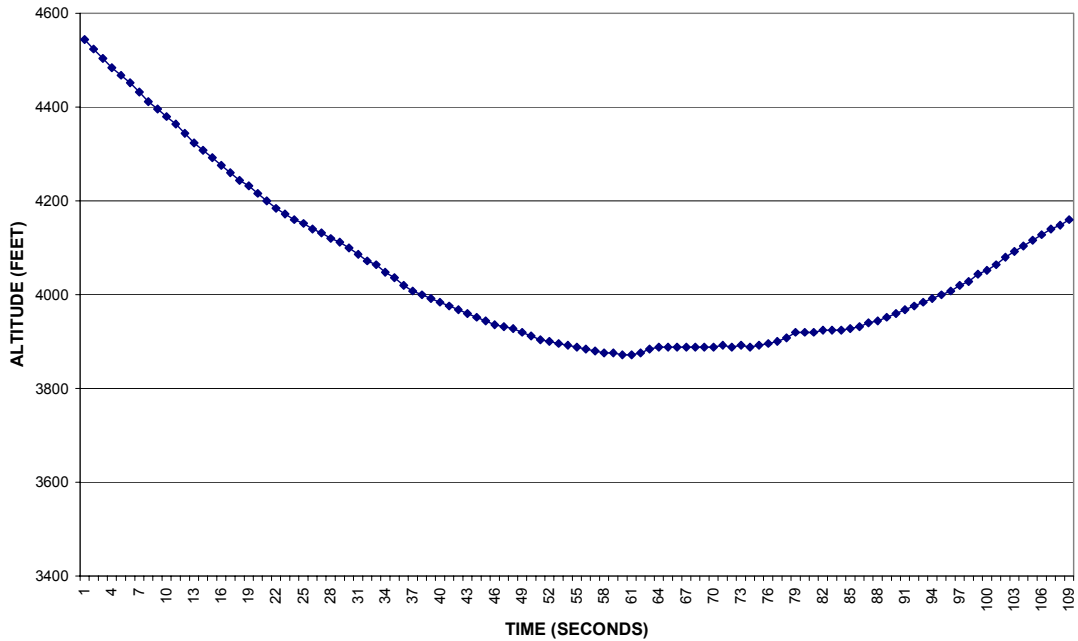
Proving Flight Two – Profile Three

As experienced on proving flight one, the aircraft commenced an approach and gently flattened out. The aircraft descended some 1600 ft before reaching straight and level flight, subsequently climbing away as the landing configuration was reached.

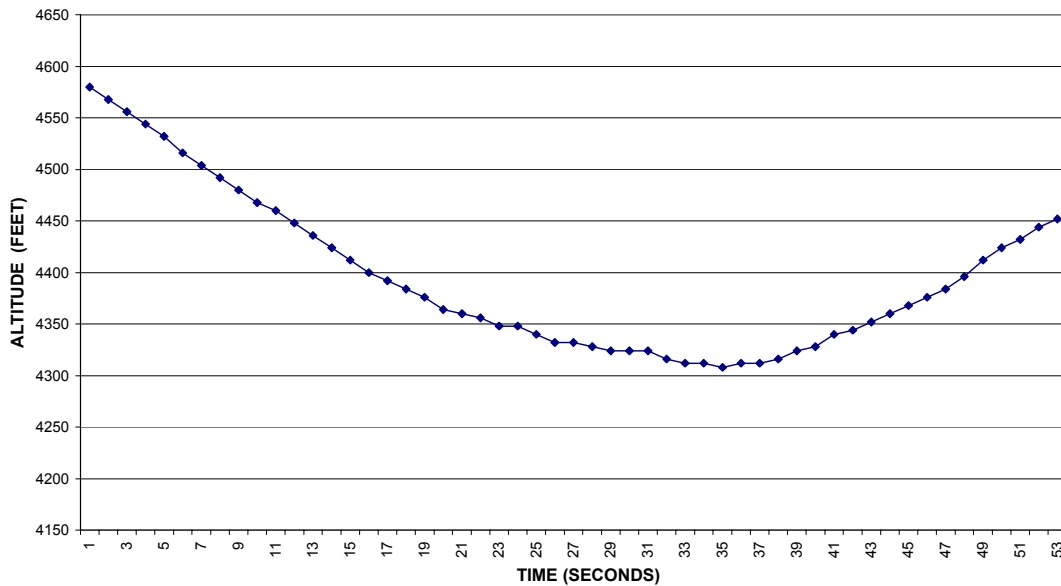
Proving Flight Two – Profile Four

The Auckland runway 05 ILS glideslope CSB signal is biased with a ‘fly up’ DDM of approximately -0.0016 to ‘trim’ the cumulative signal and generate the required glideslope angle. As expected, the approach flattened and the aircraft subsequently flew away. In this case, only 250 ft of altitude was lost prior to the aircraft climbing.

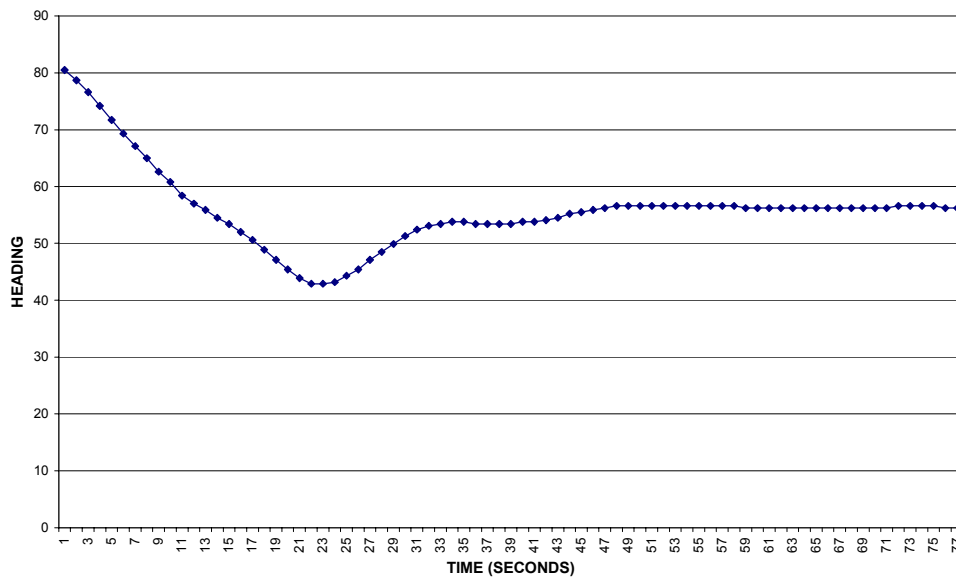
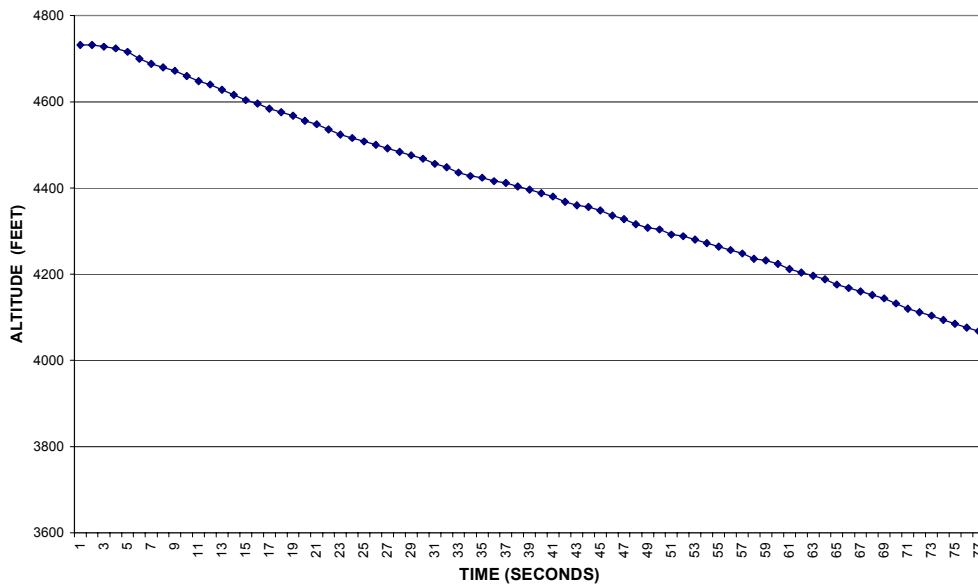
Proving Flight Two – Profile Five

It was understood that there is no technical reason why the localizer cannot transmit the same erroneous path. To test this hypothesis, the glideslope CSB signal was returned to a ‘fly down’ DDM, and the localizer left transmitting a CSB only. From an intercept heading of 080° and with an on-track indication, the APP mode was armed, resulting in an instantaneous G/S and localizer capture. The aircraft turned left to 043° then turned right on to a heading of 053° and finally stabilised on a heading of 058°. There was an initial suspicion that there was some logic related to the selected front course of 051°, and a second profile was flown to better understand this. Of interest on this first localizer profile was the recording again of a steepening vertical profile.
