Airworthiness Directive Schedule

Propellers & Propeller Governors

Hartzell Series

27 May 2021

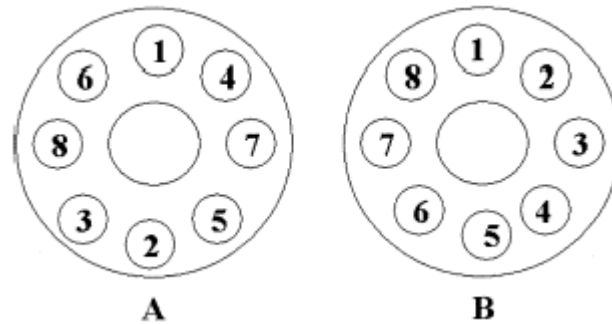
Requirement: To prevent propeller attaching bolt failures or improperly secured propellers, which could lead to separation of the propeller from the aircraft, accomplish the following:

(d) Torque all attaching bolts with a torque wrench and an appropriate adapter, to 40 ft.lbs, and then to 80 ft.lbs, following sequence "A" (shown below). Final torque all attaching bolts using sequence "B" (shown below) to 100 ft.lbs to 105 ft.lbs. Safety wire lock all attaching bolts in a manufacturer approved manner.

Note 1: A bolt with P/N A-2047 has the letter "H" stamped inside a triangle on the bolt. A bolt with P/N B-3339 has the P/N stamped inside the cupped head.
