vector

Cleared for Takeoff

Before You Go

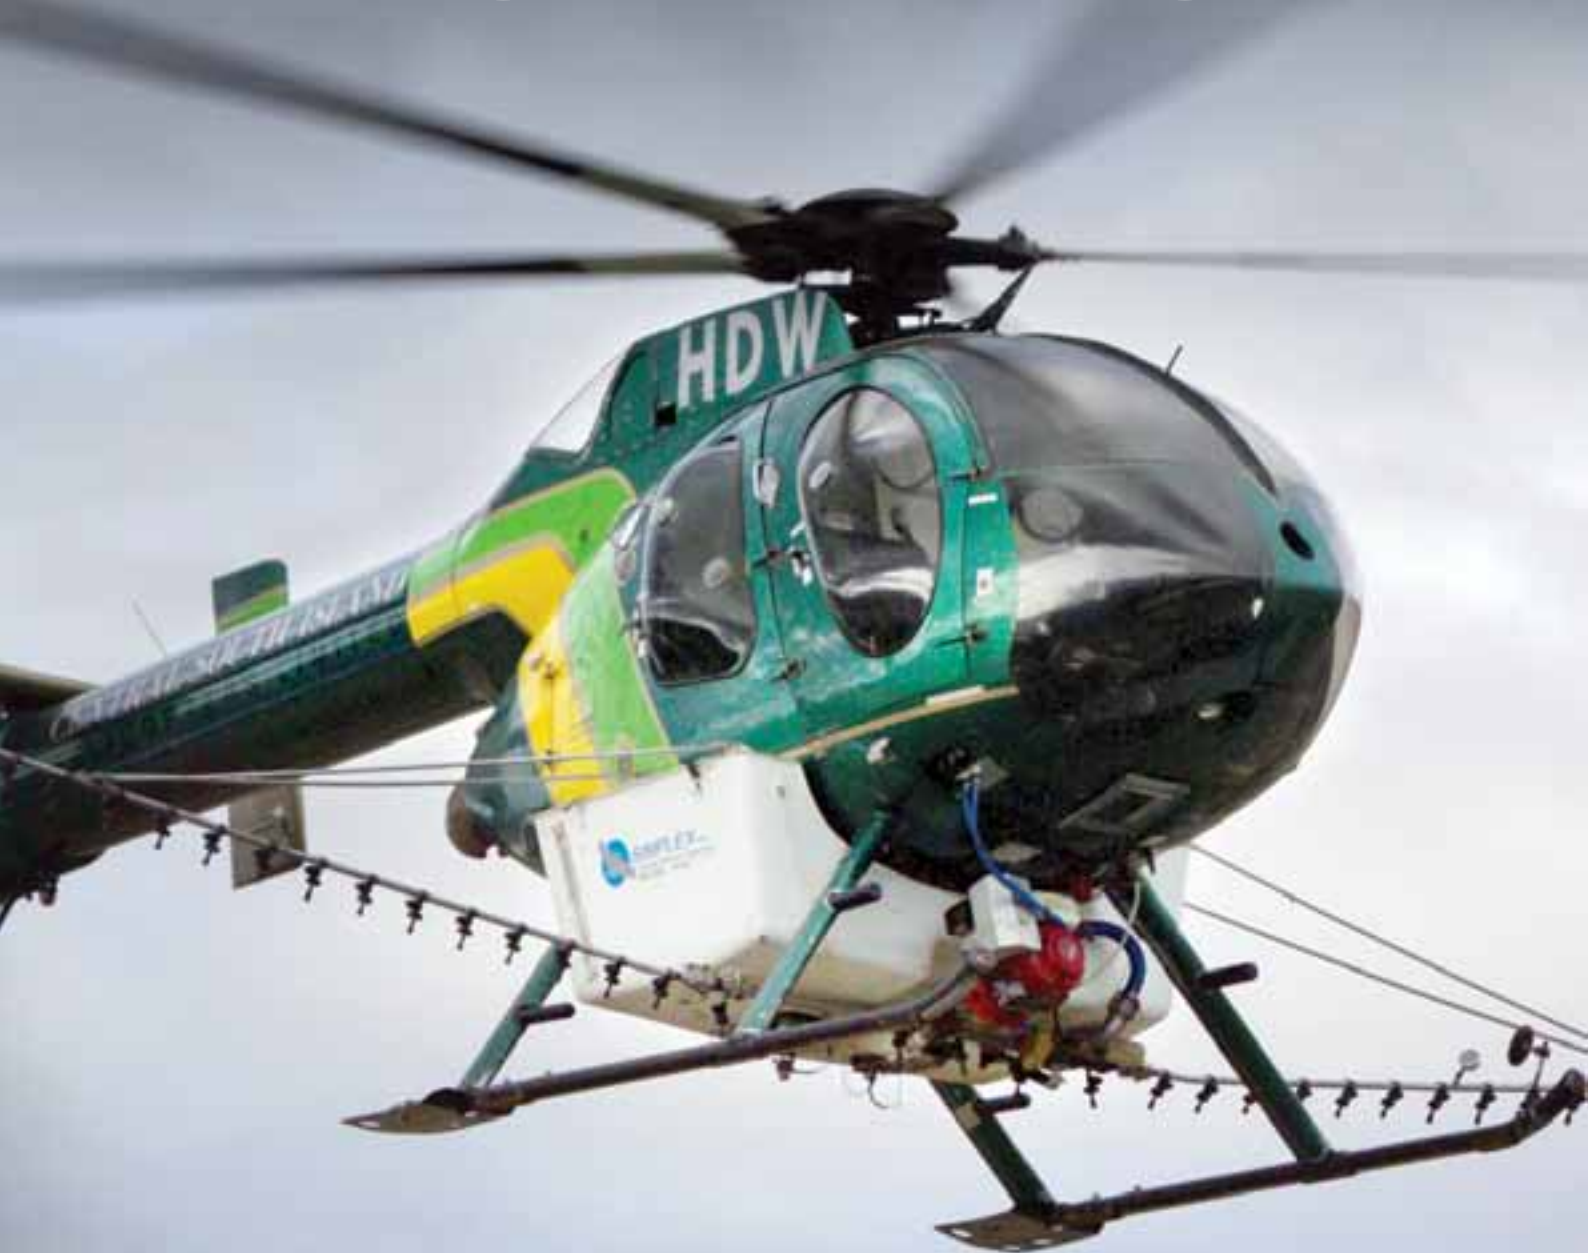
Cover: This MD500N (no tail rotor) is configured for agricultural spraying. See *Autumn Ag Ops* on page 4.

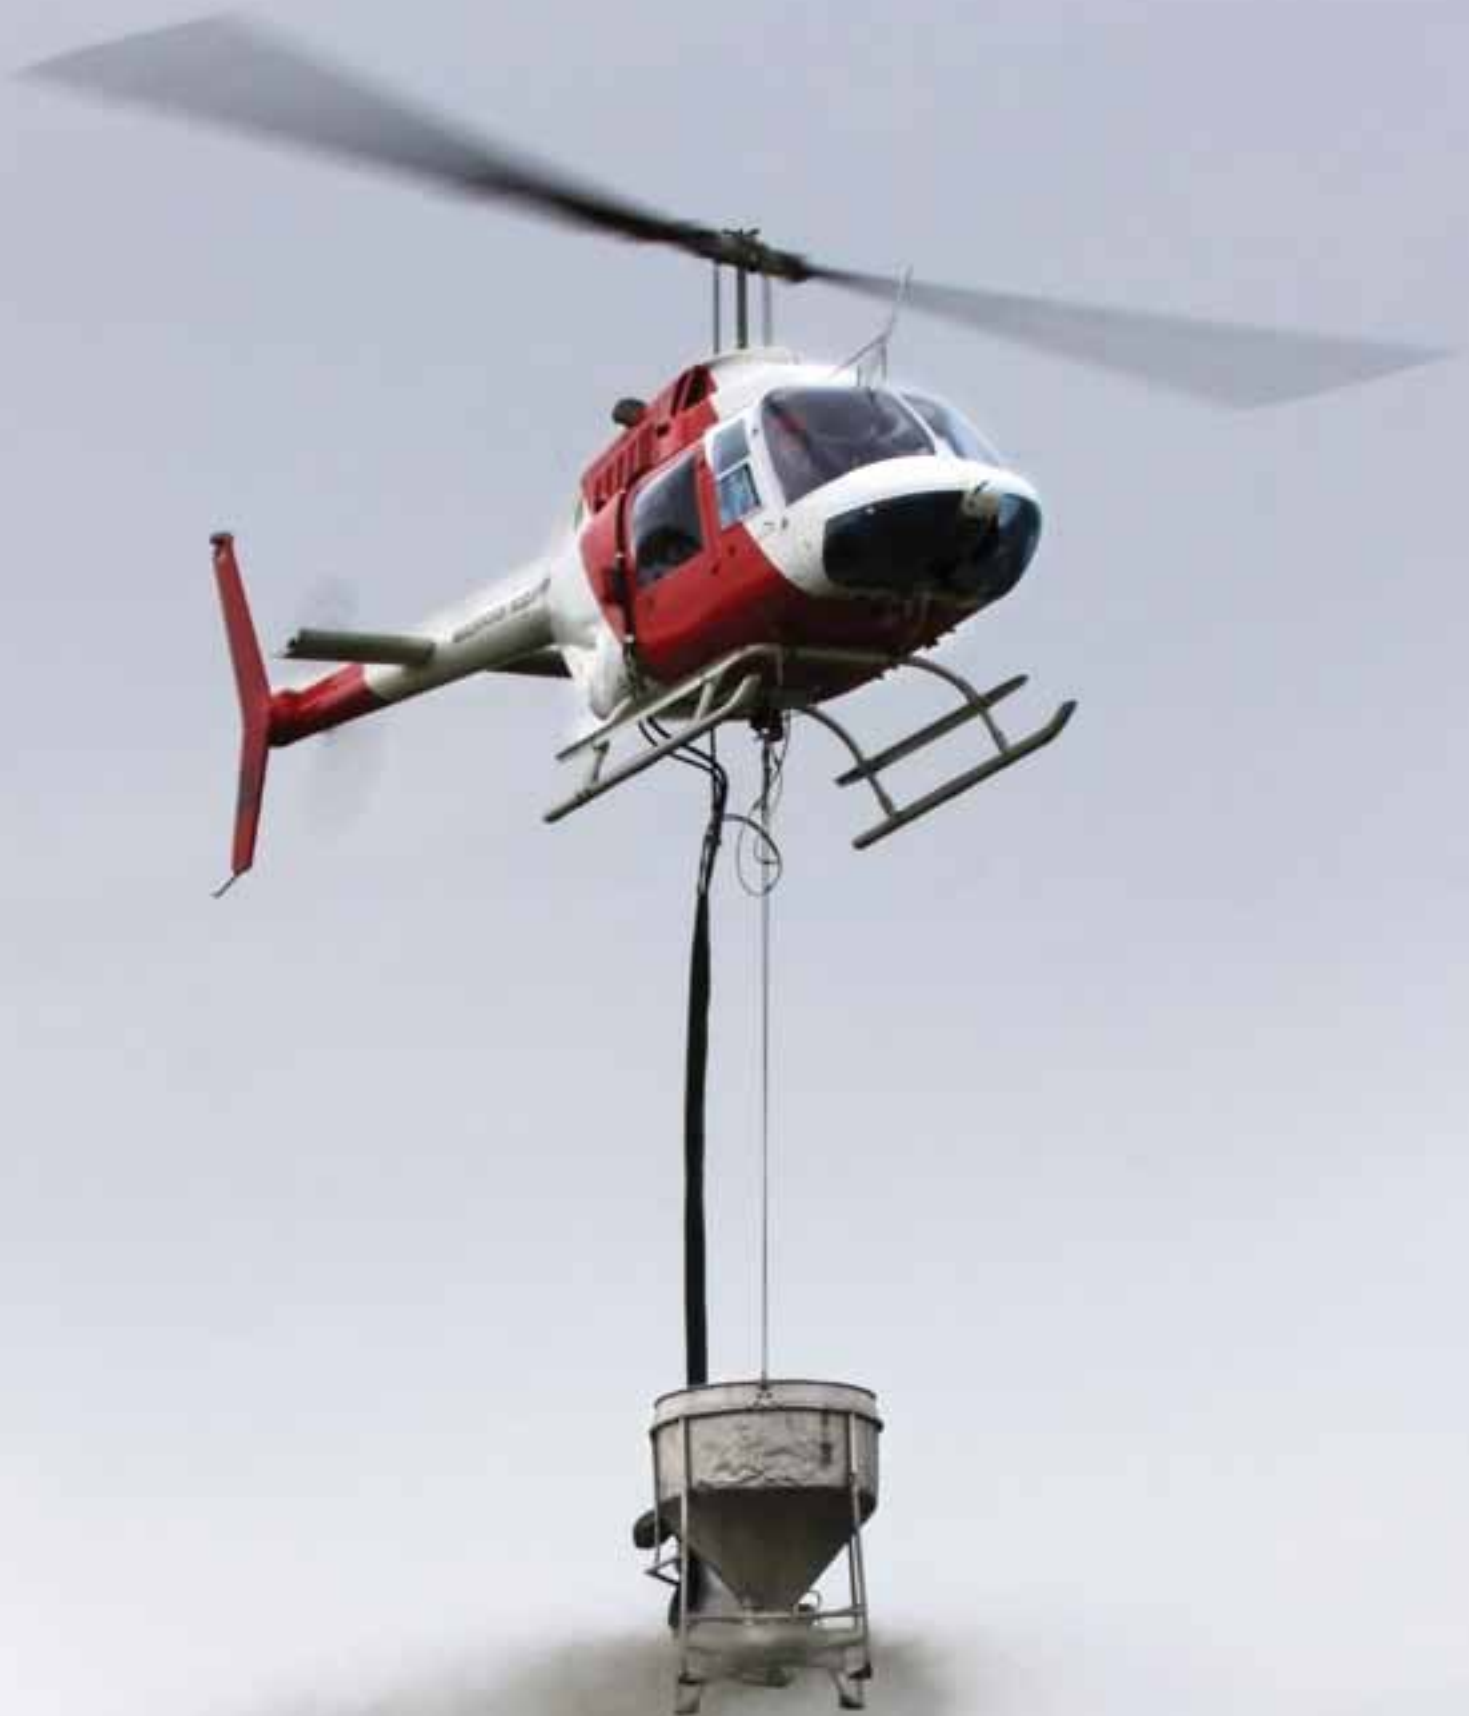
When thinking of helicopters in agricultural operations, it is easy to assume they carry out only spraying, but helicopters are playing an increasing role in applying fertiliser, as seen in this example. Photo: Gavin Conroy

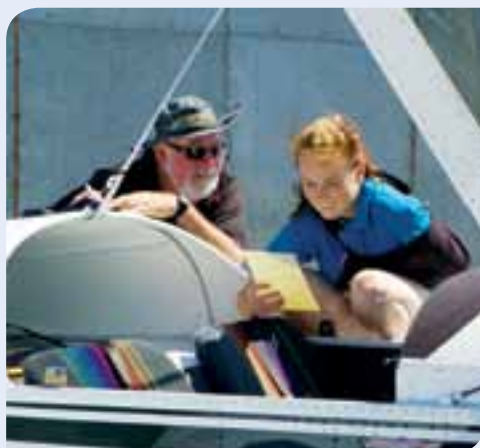
Nicole Patterson checks the aircraft documentation. In this competition scenario, the wrong Airworthiness Certificate was in the aeroplane and there was no Technical Log.

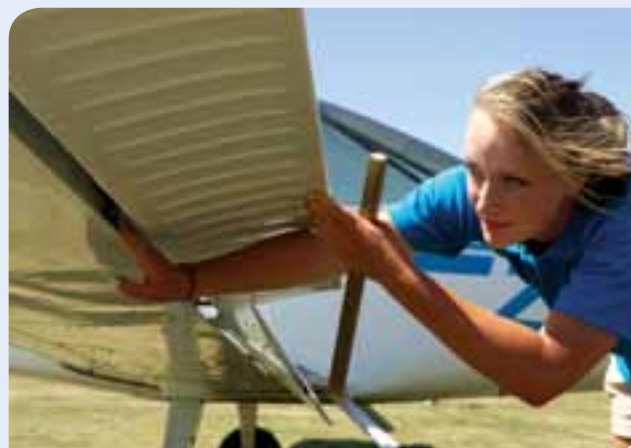
Beware the finger traps some ailerons can pose. Keep a firm grip on the trailing edge while checking pushrods, locknuts and the like, as demonstrated by Nari Casley.

check the flaps, ailerons and upper and lower wing surfaces. Some ailerons are 'finger traps', so be careful in these areas. Check the wingtip for 'hangar rash', the condition of the navigation light, and strobe light, if fitted.

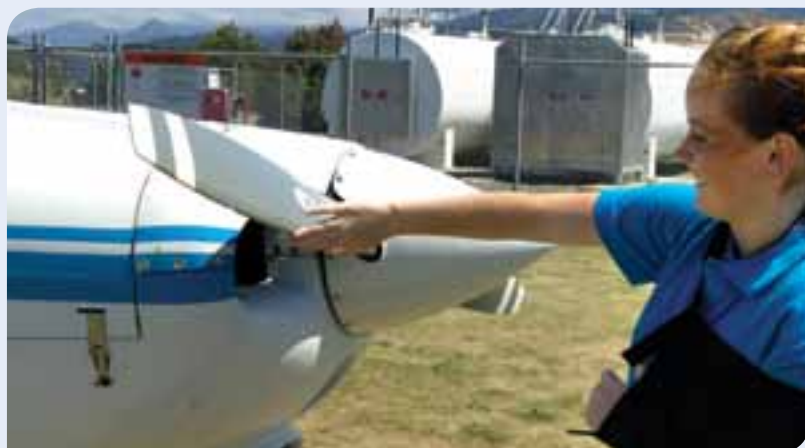
Keep clear of the propeller arc, as shown by Nicole Patterson, and take care when checking the leading edge – there can be sharp-edged nicks present.

We check the leading edge for damage, operation of the stall warning vane if applicable, unobstructed fuel vents and pitot/static head(s), removing any covers from these. On a high-winged aeroplane, we might need a stand or stepladder to access the fuel caps – don't forget to put it away when finished, or that 'clunk' when you taxi off might signal the end of your flight. While you're up at the fuel caps, this is the ideal time to check the wing upper surfaces and the cabin top. Know where all the fuel drain points are, and where to dispose of fuel samples.

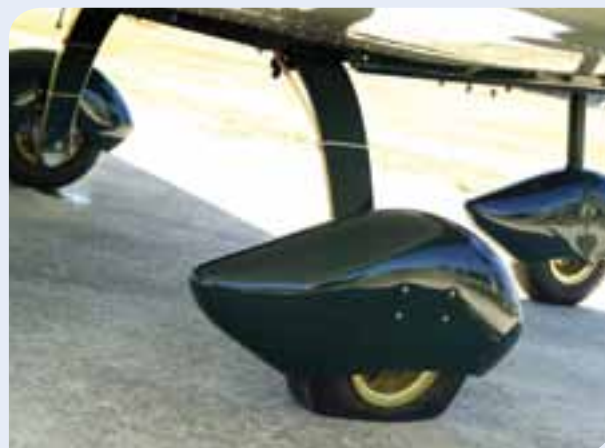
The flat tyre might be obvious, but what about that stain on the ground by the left main wheel?

At the main undercarriage, check the tyres, or what you can see of them. Under-inflation can be hard to detect, so if in doubt, use a pressure gauge or seek advice. Look at brake condition, hydraulic line integrity, and oleo extension. You should know how many fingers' worth of oleo extension should show at normal weights. While 'down and dirty' have a look at the wing lower

During your walk-around, check the ground underneath for signs of oil, fuel, or hydraulic fluid leaks. Any suspicious stains should be investigated and the cause remedied before flight.
