# vector

## FLYING AROUND **VOLCANOES**

Ageing aircraft  
wiring

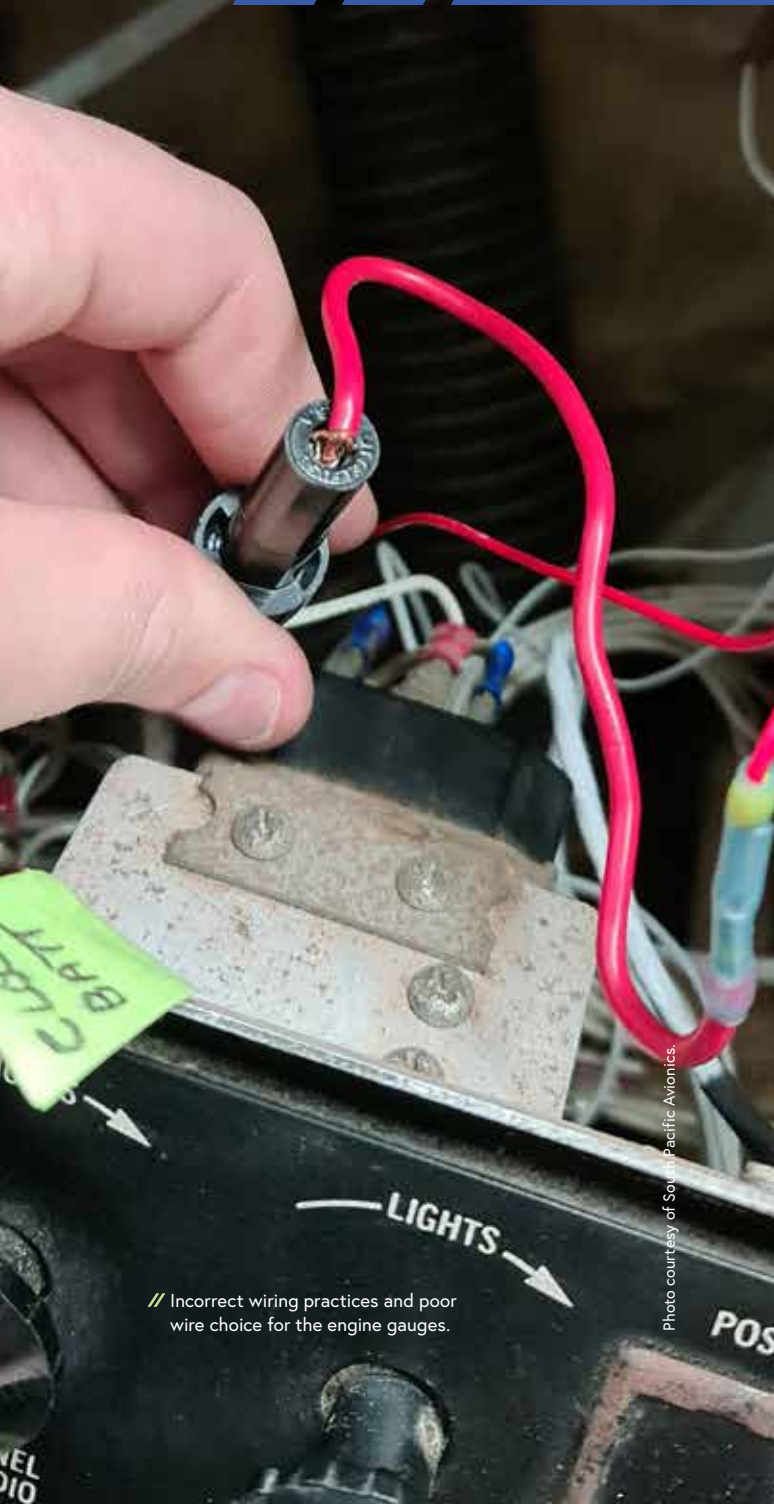
// Incorrect wiring practices and poor wire choice for the engine gauges.

» As a consequence, it's degrading. Wires chafing against each other, incorrectly supported in the wiring harness, and rubbing against pipes or aircraft structure all eventually cause wire insulation to deteriorate. It eventually fails one way or another by having an open circuit, or even more seriously, a short circuit.

Items and techniques used 30 years ago to repair wiring did not seal the repair from the environment, leading to likely failure sooner or later.

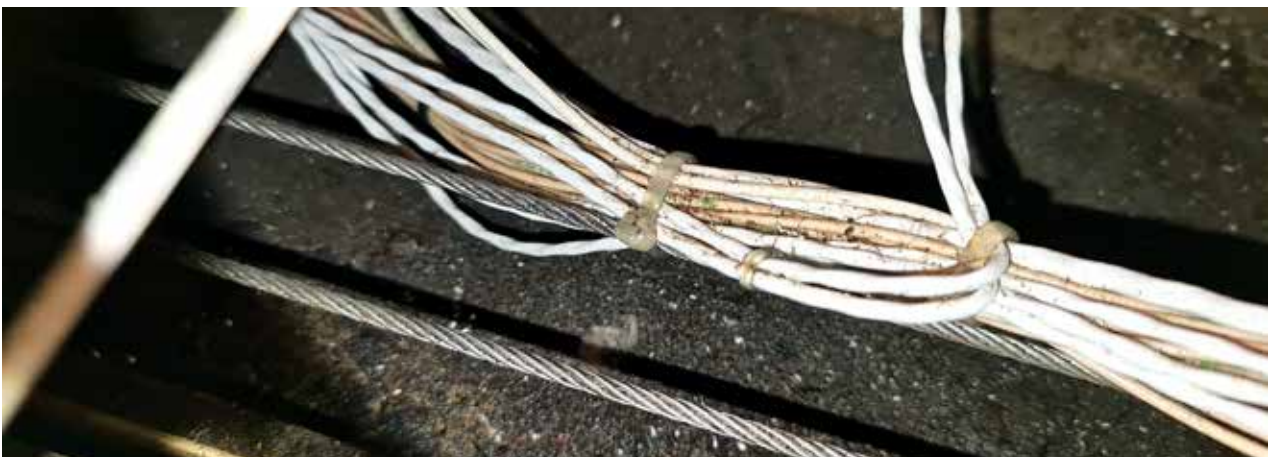
// Wiring bundle attached to a flight control cable – note the metal shavings on the wire.

- inappropriate wiring repair
- incorrect routing of modification wiring
- inappropriate clamping and wiring support
- structural contact, and
- lack of a 'clean as you go' philosophy (illustrated by the presence of lint, dust and debris in between wiring bundles).

The working group identified a whopping 2,256 such issues. On 39 aircraft.

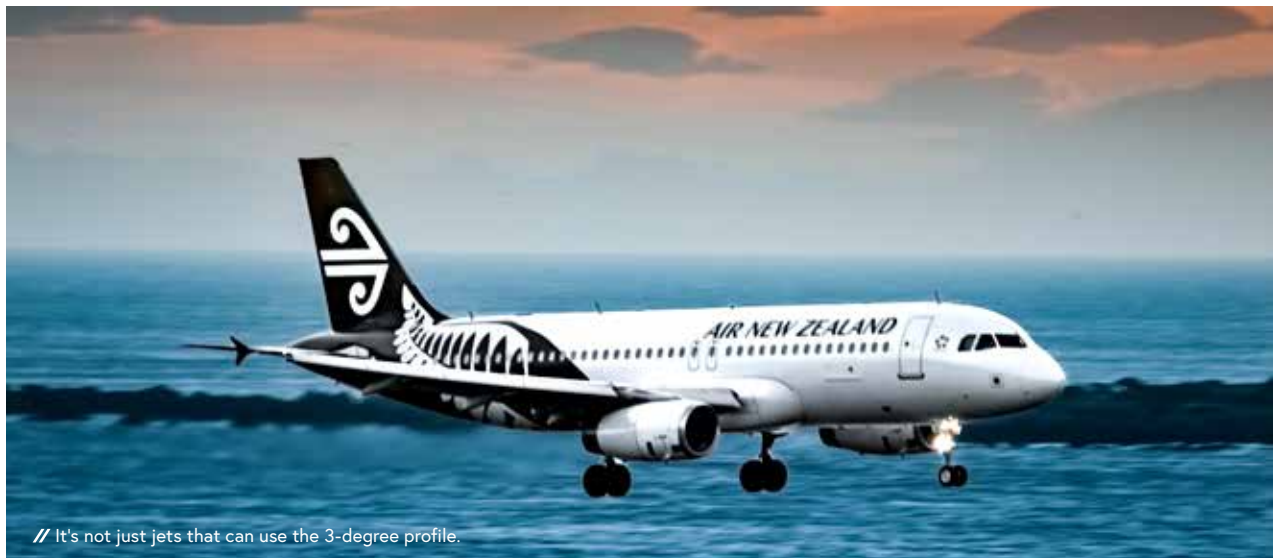
// It’s not just jets that can use the 3-degree profile.

The accuracy of the PAPI wavers the closer to the ground you get. So the advice is, at about 200 feet AGL, move from monitoring what the lights are telling you, to scanning for the runway touchdown markings – ‘fixed distance markings’ – and where your aircraft is in relation to them. »

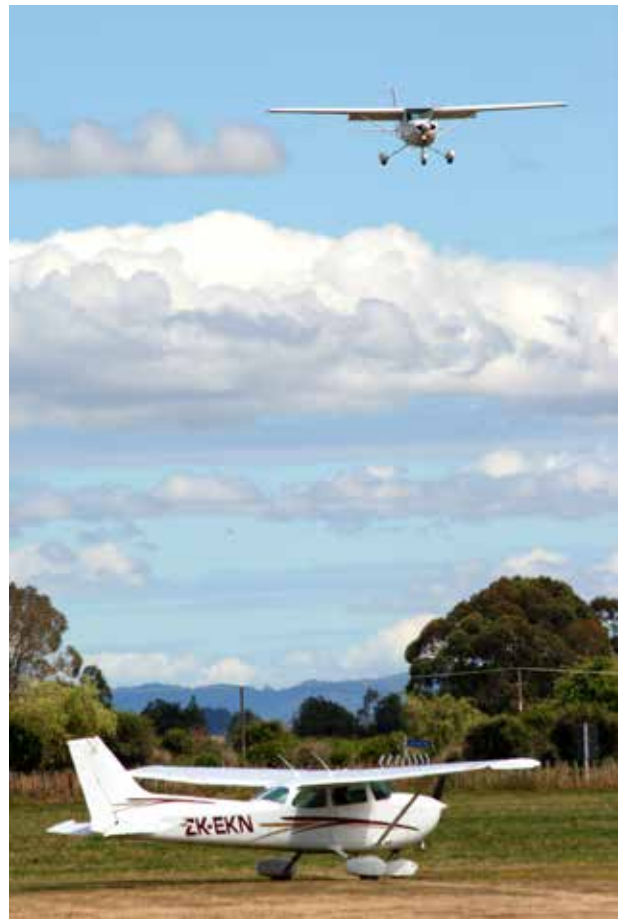
// Chipmunk at Walsh Memorial Scout Flying School clearly coming in at least 50 feet across threshold.

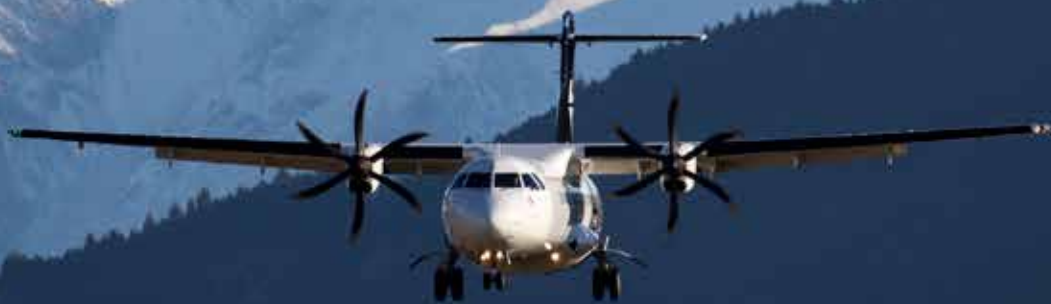
1 "Unauthorised altitude penetration"

// New Air New Zealand ATR procedures at Queenstown have a higher navigation accuracy, and get quite close to the boundary of controlled airspace and the general aviation area.
