**CIVIL AVIATION AUTHORITY
OF NEW ZEALAND**

**AIRCRAFT SERIOUS INCIDENT REPORT
OCCURRENCE NUMBER 00/2518
B767-319ER
ZK-NCJ**

**NZ 60
'ERRONEOUS' GLIDESLOPE CAPTURE,
AUTOCOUPLED APPROACH,
AND GO-AROUND**

**FALEOLO AIRPORT, SAMOA
29 JULY 2000**

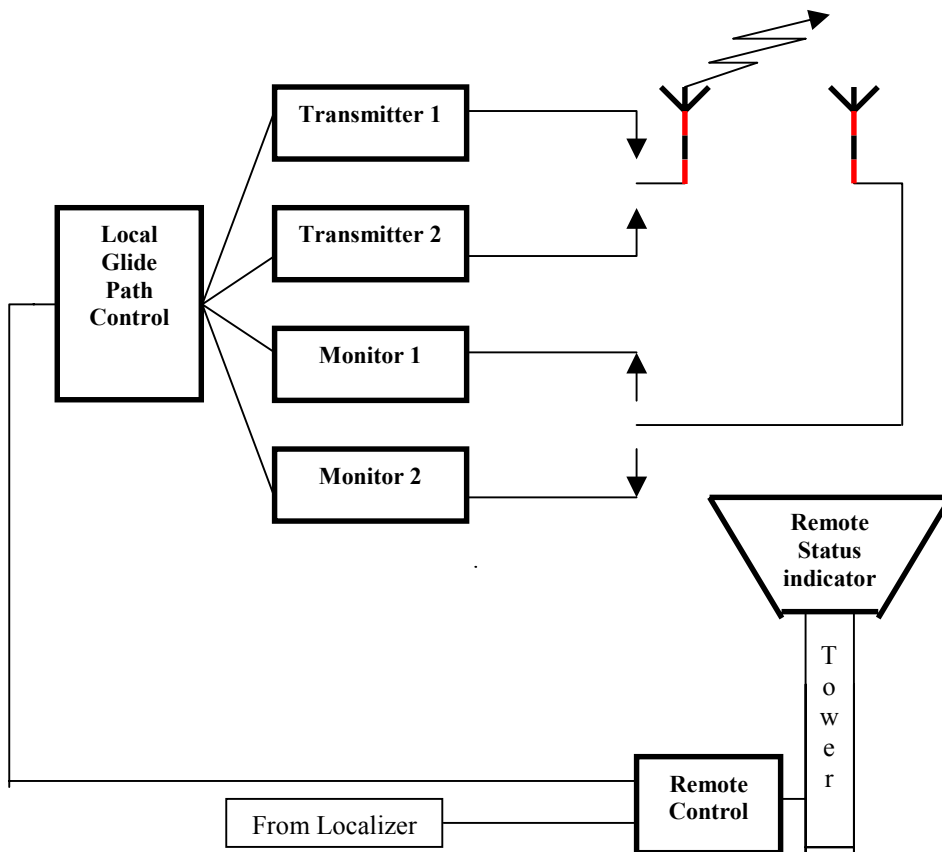
Schematic of glide path equipment

It was later established that the ILS glideslope transmitter had inadvertently been left in control (monitor) bypass mode, with the unserviceable transmitter selected. In the bypass mode, the glide path transmitter executive monitor was unable to shut down the faulty transmitter or to transfer to the serviceable transmitter. The result was the radiation of invalid glideslope information consisting solely of the carrier plus side bands (CSB) signal component. The side bands only (SBO) signal component was missing from the glideslope transmission.

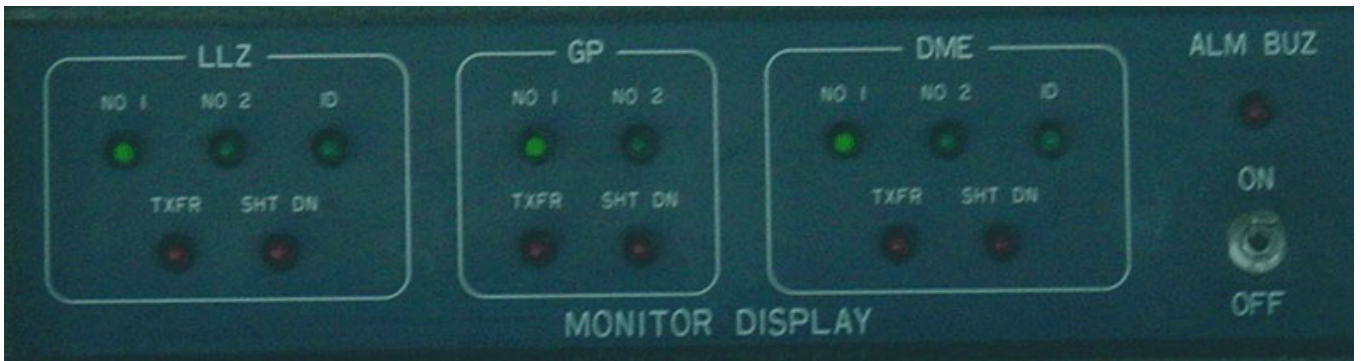
Tower Remote Status Indicator Panel at Faleolo

A tower ‘monitor’, as it is often referred to, is specified in ICAO Annex 10 as a remote control and indicator and indicates the operational status of the respective navigation aid to the controller. The remote indicator is usually simple, e.g. a green light for a normally operating system and a red light for a failed system. To reset the ILS system (in the case of Auckland) the tower staff selects the other runway and then reselects the ILS to the desired runway. Once the equipment is transmitting, the equipment (field) monitors are the sole arbiters of determining whether the equipment should remain transmitting. In the Faleolo tower only the status of the ILS is displayed and no selections are possible other than to silence the audible alarm. At the base of the Faleolo tower is the ILS remote control. This panel is the communication point for the LLZ and GP. It shows the transmitters selected, remotely (at this panel) or local (at the LLZ or GP hut on the field), any maintenance or executive alarms, transmitter transfer or shut downs, and if the equipment is in control bypass, i.e. the executive monitor is **NOT** in control.

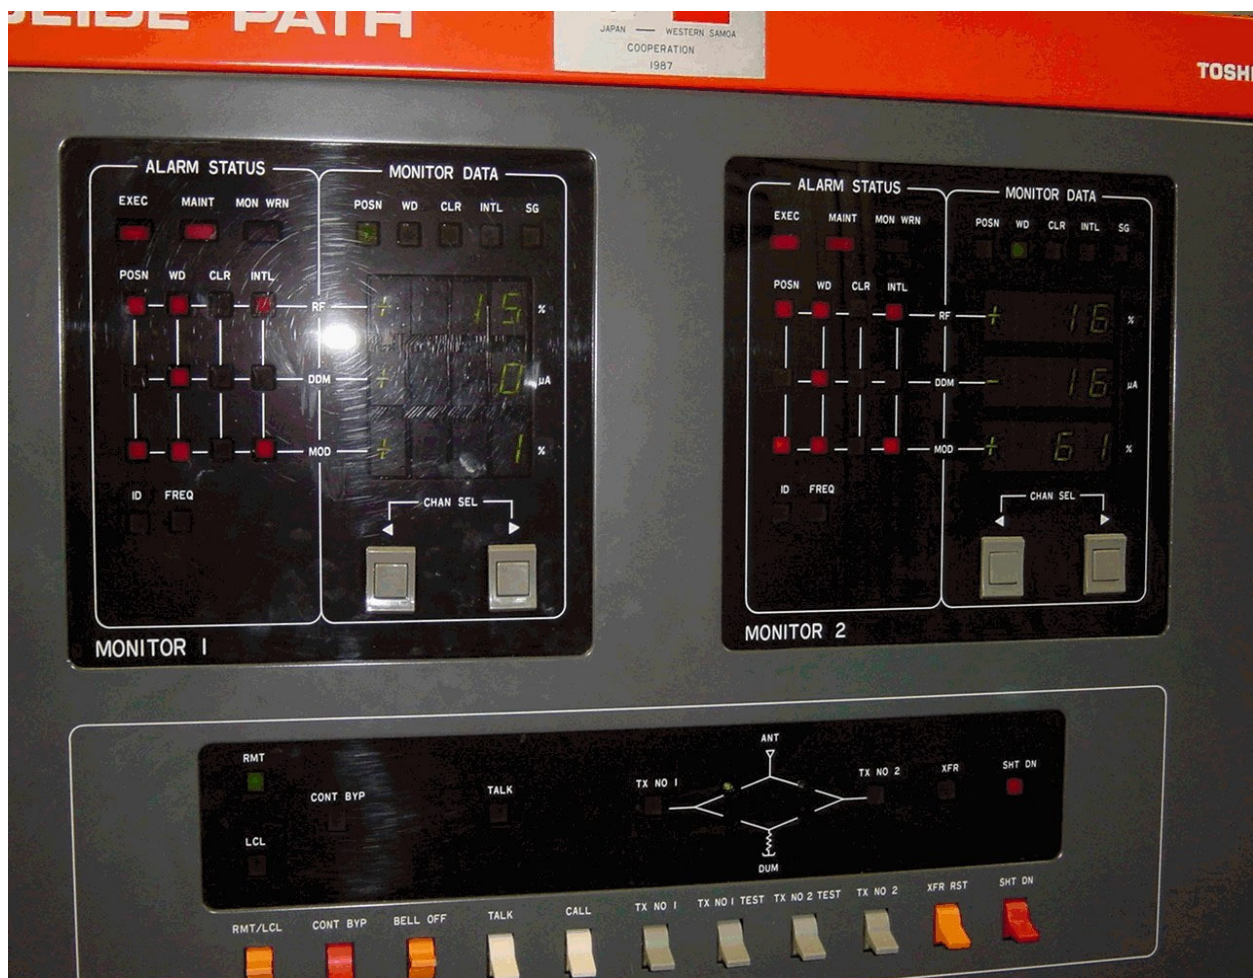
Glide Path monitors and control panel in the GP equipment shelter on the field at Faleolo

Manufacturers generally provide switching sequences and functions to override equipment monitoring during maintenance. This enables out of tolerance information to be transmitted and allows parameter adjustment during ground repair, maintenance and flight calibration. To prevent nuisance alarms to the tower during maintenance procedures, status alarms and indicators also need to be capable of being deactivated.

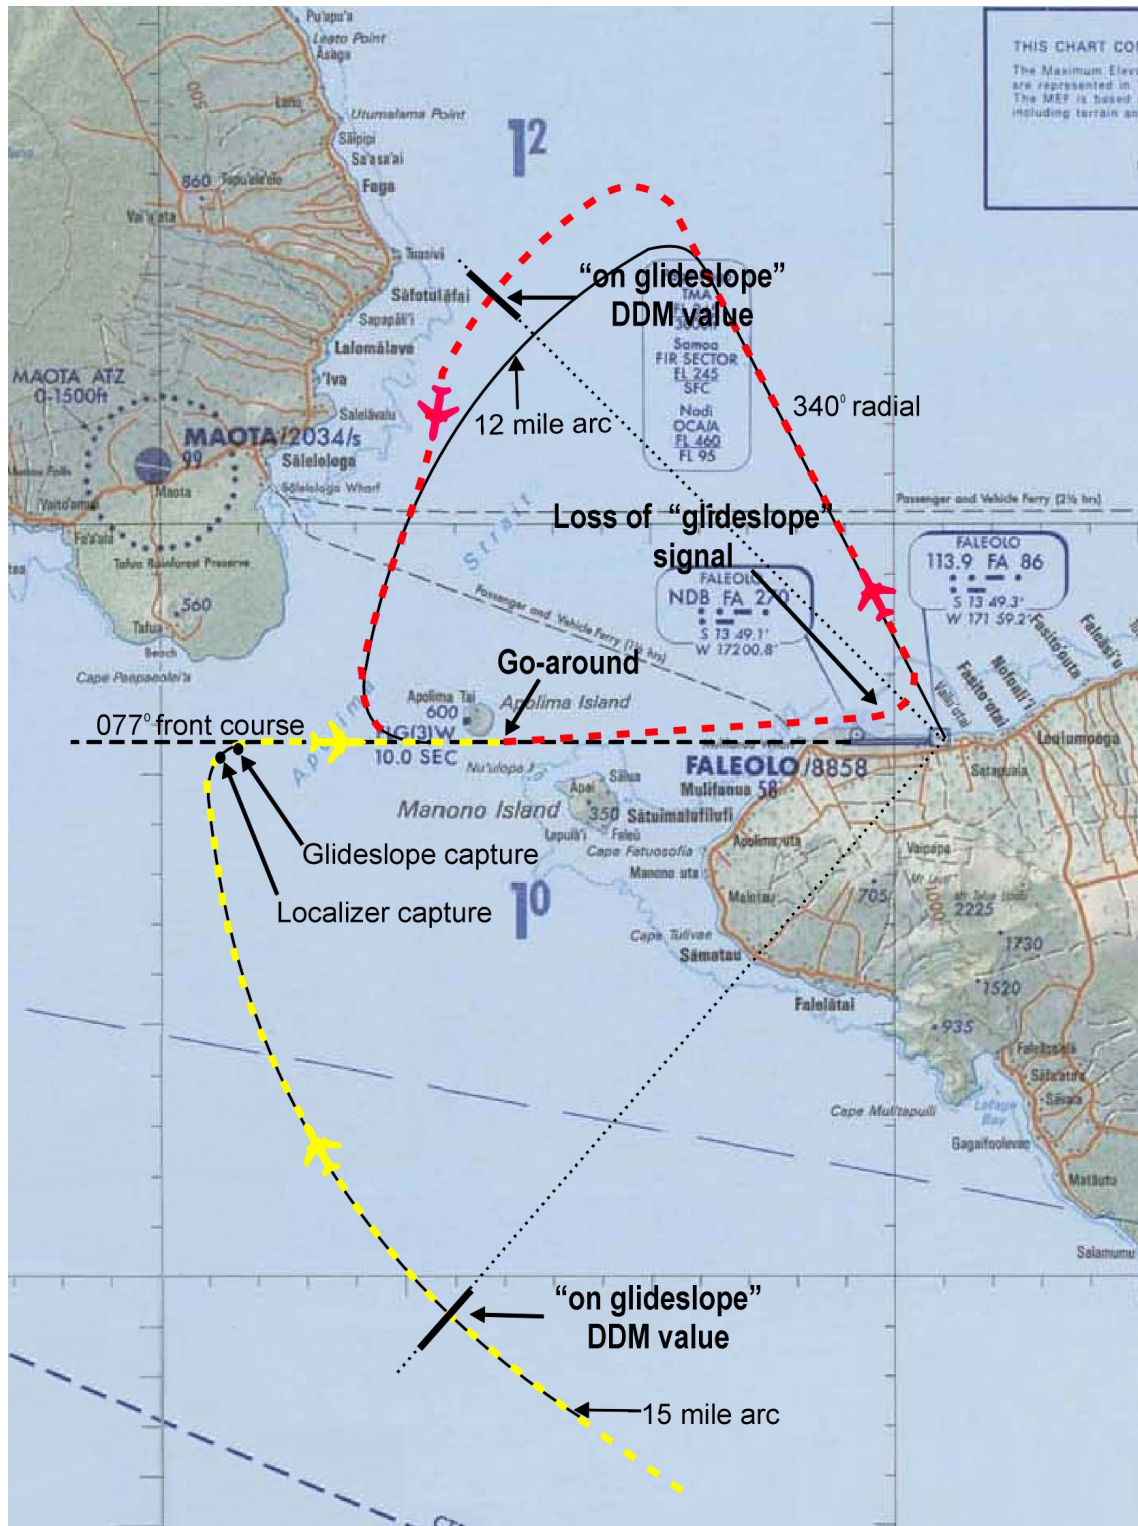
Flight Path of NZ 60

NZ 60 Profile - First Approach Apia

NOTE: Distances shown on the above profile are approximate. The FDR fitted to ZK-NCJ does not record DME. Distances were computed using IRS longitudinal information adjusted for latitude and corrected for the residual error.

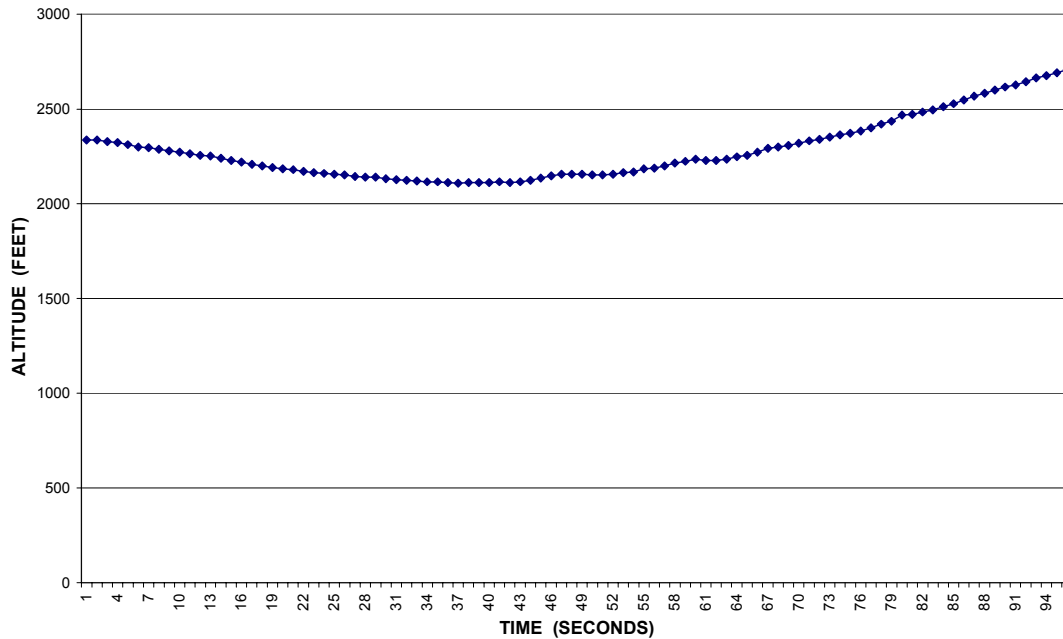
Proving Flight One – Profile Three

1.16.1.3 Third Approach – Flaps Up 240 KIAS

For the third approach the aircraft was positioned to intercept the glideslope from the altitude capture mode to ascertain whether the aircraft would pitch down at the glideslope capture point. The aircraft was positioned at the glideslope capture point at flap up, 240 KIAS. At glideslope capture the ROD was 200 fpm in a level-off manoeuvre. After glideslope capture the aircraft slowly drifted down initially then commenced a gentle climb.

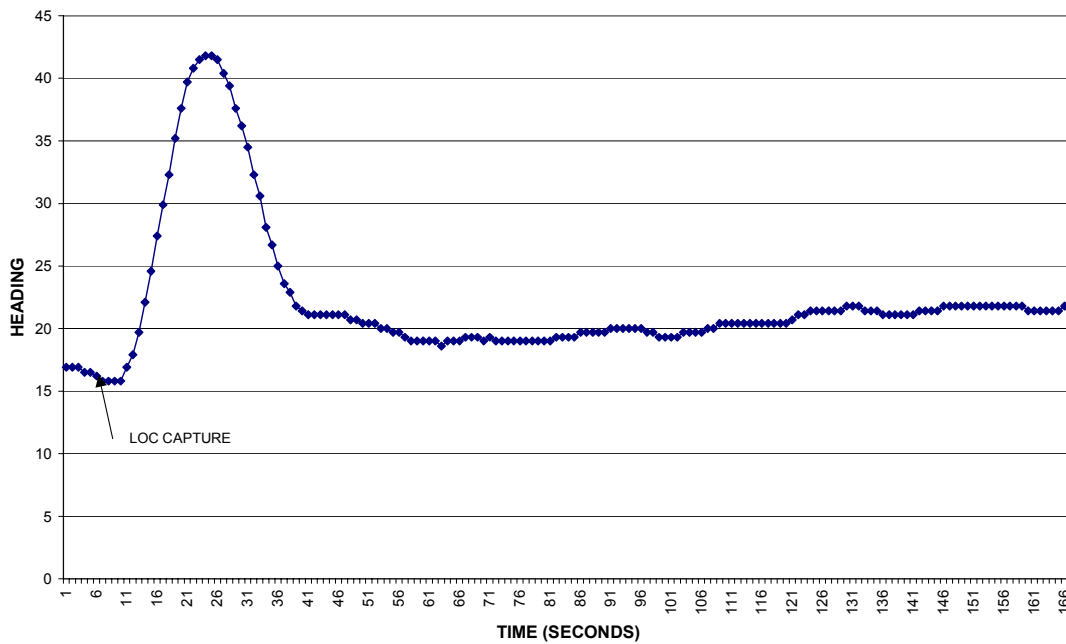
Proving Flight Two – Profile Six

1.16.2.6 Sixth Approach – Flap 1, 220 KIAS, Localizer CSB Only

On the second localizer profile, the localizer was armed and captured from a heading of 016°. A right turn onto a heading of 042° followed, with a subsequent left turn onto 021°, stabilising on 020° with a very slight bias towards further small turns to the left. With an on-track indication on the EADI, the aircraft flew through the centreline of Runway 05 towards the rising terrain to the Northwest of the airfield.

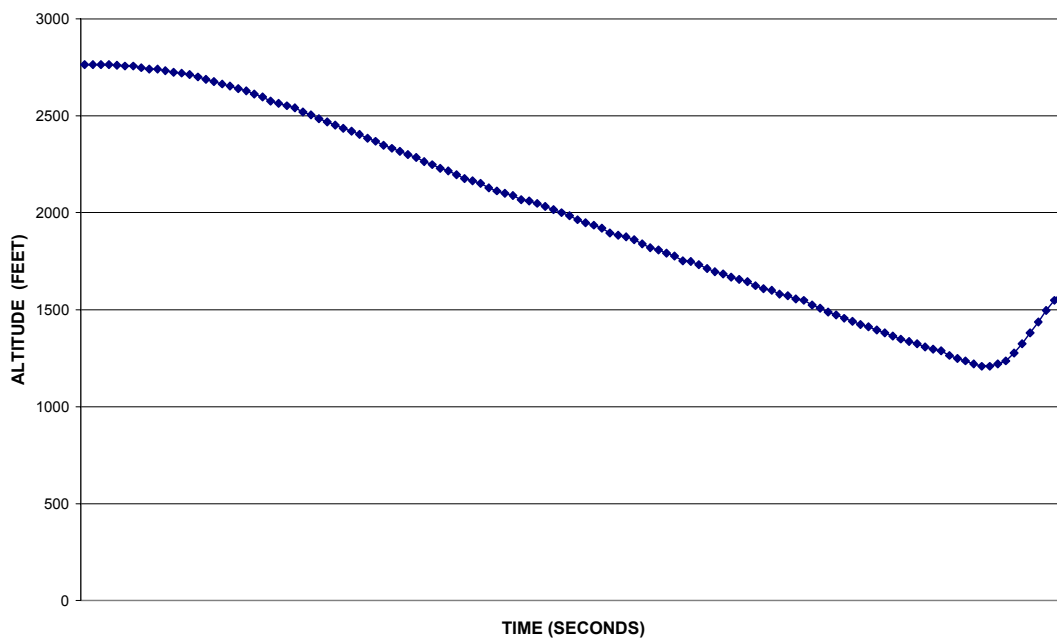
Proving Flight Two – Profile Seven

1.16.2.7 Seventh Approach – Flap 1, 220 KIAS, Normal Glideslope and Localizer Transmission

Profile 7 was flown with the ILS restored to normal operation. The aircraft positioned around the northern arc to observe ‘normal’ indications. As the aircraft travelled around the arc toward the localizer the Standby Attitude Indicator’s glideslope deviation indicator moved erratically as it caught the false slopes off other lobes. This was unlike the steady ‘on glideslope’ indication noted around the arc on the previous proving flight. As anticipated, no glideslope information appeared on the EADI until the track was within 90° of the selected front course. Once the EADI glideslope deviation indication was displayed, normal movement of the glideslope deviation indicator was observed as the aircraft approached the glideslope from below.

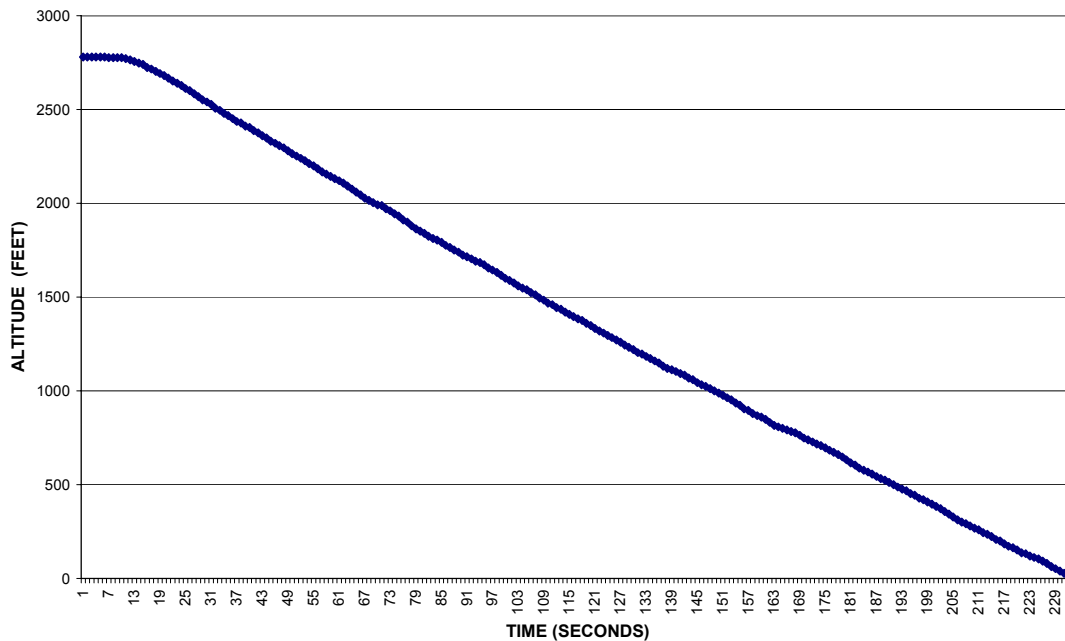
Proving Flight Two – Profile Eight

1.16.2.8 Eighth Approach – Flap 1, 220 KIAS, Normal Glideslope and Localizer Transmission

A DDM value of 0.01 DDM was noted at glideslope capture.

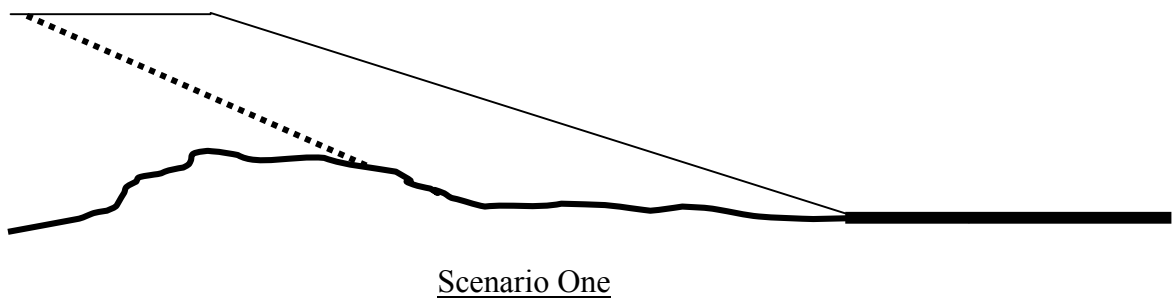
- Scenario one is where the aircraft captures the 'glideslope' prior to actual descent point and on a profile close to the expected 3°. If the erroneous glideslope is not detected, terrain/obstacles may be a factor prior to the briefed decision point.

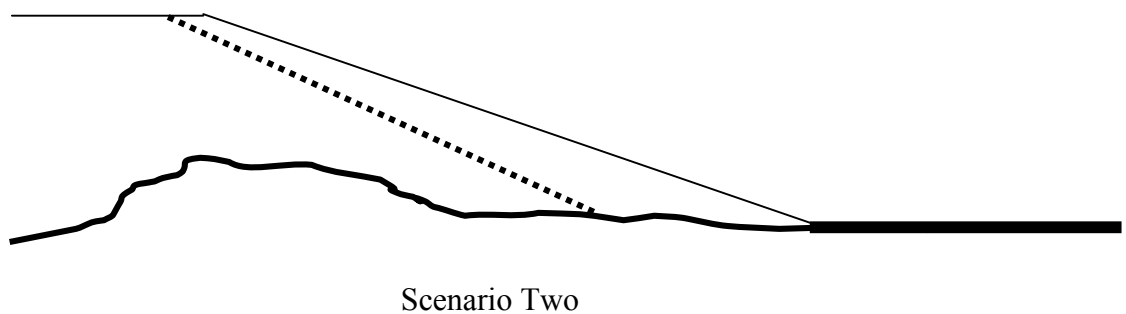
- Scenario two is where the aircraft captures the 'glideslope' slightly short of the true glideslope intercept point and flies a profile steeper than but close to the expected 3°. The crew may not identify the discrepancy with a glideslope intercept distance/altitude check. The resultant profile will take the aircraft to a point short of the true decision point.

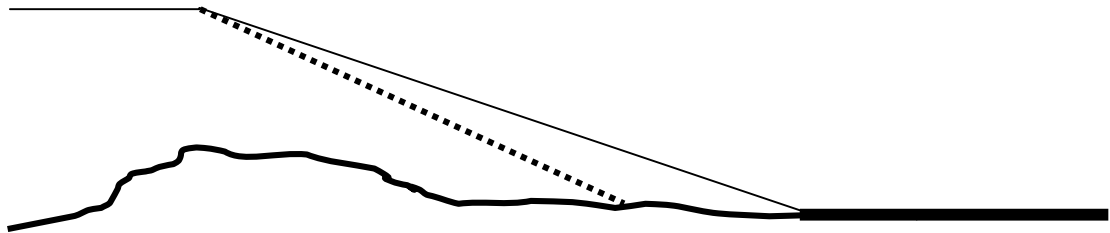
Scenario Three

- Scenario three is where the aircraft captures the ‘glideslope’ at the correct intercept point, but not on a true glidepath. The profile flown will not necessarily be a 3° glidepath and there is nothing to ensure the aircraft maintains the path. If the path is greater than 3°, the aircraft will still fall short of true decision point.

While the first scenario may be detected with a distance/altitude check at glideslope intercept provided that point is known, this statement does not hold true for the other two scenarios. Faced with a seemingly valid glideslope indication with no warnings present on the flight deck, the crew will inevitably accept the glideslope. On all the profiles the aircraft is not receiving glideslope guidance and therefore the flight path cannot be predicted.

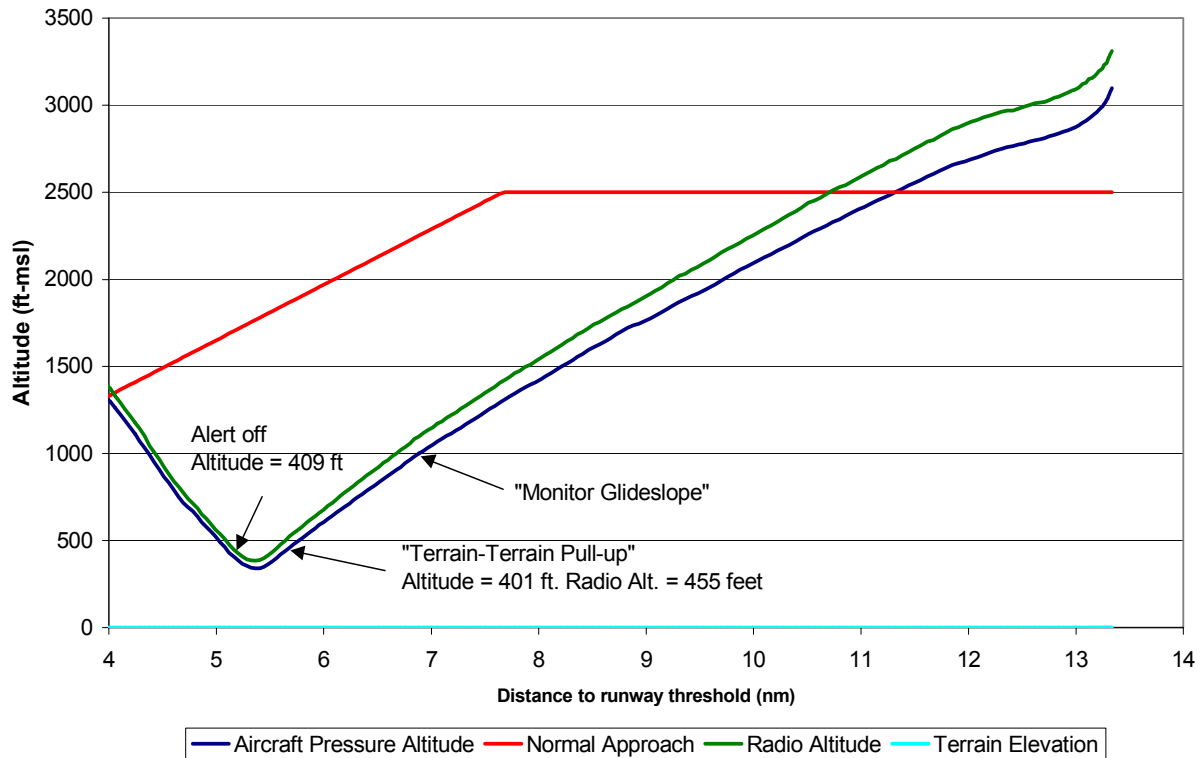
NZ 60 Profile Depicting Computed EGPWS Warning Altitude

Although not installed on ZK-NCJ the following chart traces the approach flight path of NZ 60 and indicates the altitude at which a current generation EGPWS would have provided a “TERRAIN, TERRAIN PULL-UP” warning.
