# VECTOR

*Pointing to Safer Aviation*

# Tiedown Techniques

Each year aircraft are needlessly damaged by wind gusts because of inattention to weather forecasts, negligence or inadequate tiedown measures. With the 'windy season' approaching, it is a good time to brush up on recommended picketing techniques and other precautions against wind damage to parked aircraft. The advice below includes construction details for permanent tiedown anchors.

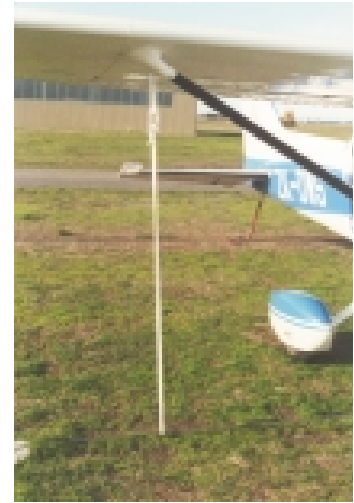
Some aerodromes utilise continuous lengths of parallel wire ropes passed through U-bolt anchors and fastened at the ends of the line with wire rope clips. The distance between the wire ropes will depend upon the types of aircraft that will use the tiedown area.

Tiedown chains (or ropes) are attached to the wire rope with roundpin galvanised anchor shackles.

This allows the tiedown chains to 'float' along the wire rope and gives a variable distance between anchor points so that a variety of large, medium, and small aircraft can use a vertical tiedown without loss of space. The vertical anchor and the flex in the wire rope significantly reduce impact loads that may occur during gusty wind conditions.

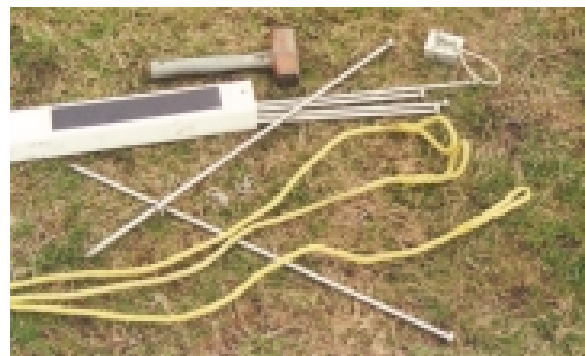
A lightweight set of pickets utilising stainless steel rods and twisted shackles stored in a plastic (downpipe) tube.

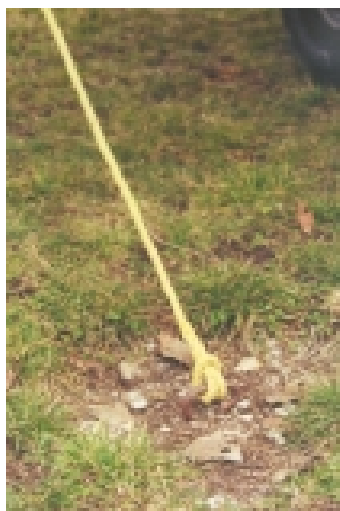
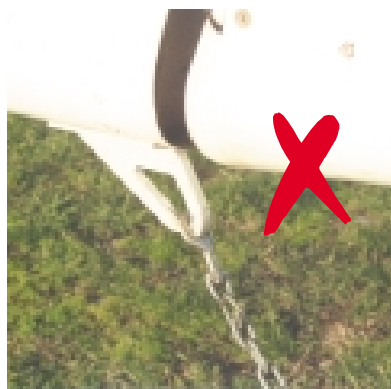
*Dog-chain type clips should not be used when picketing, as they are not strong enough.*

attached to the aircraft. Chains are often used with the parallel wire cable system – in this case the vertical anchor and the flex in the wire rope significantly reduce impact loads. If chains are used, they should be secured without slack and all fittings must be equally as strong – dog-chain type clips are not strong enough, round-pin galvanised anchor shackles should be used.

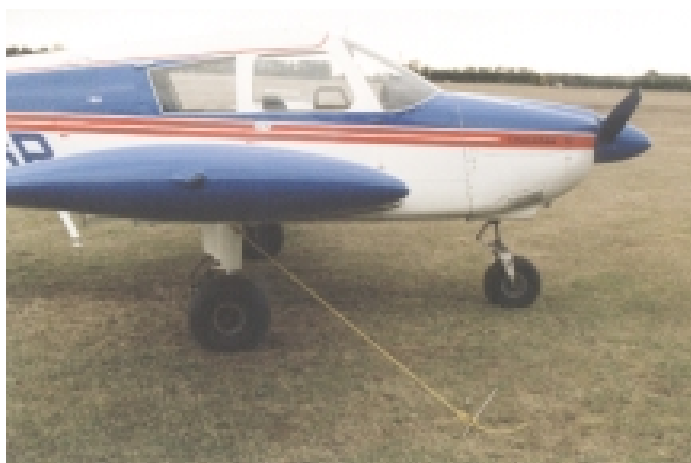
Ideally, the aircraft should be placed so that underwing ropes can be led to points one metre outboard and two metres forward of the underwing attachment point as pictured below.

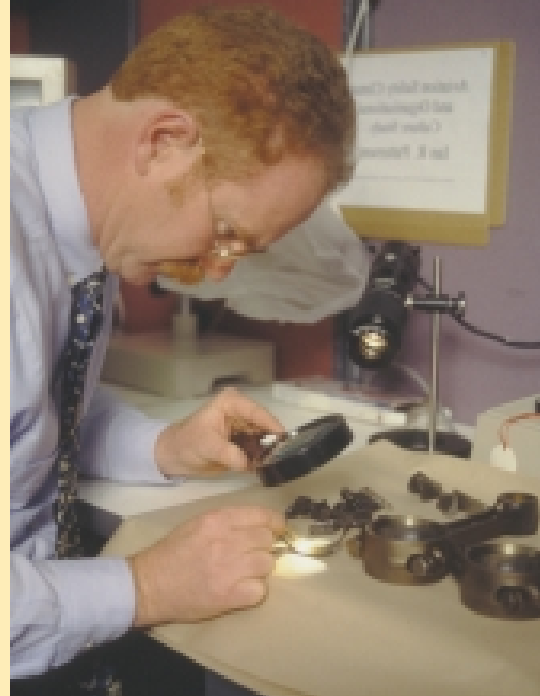
A CAA Accident Investigator inspects a crankshaft bearing from a failed engine

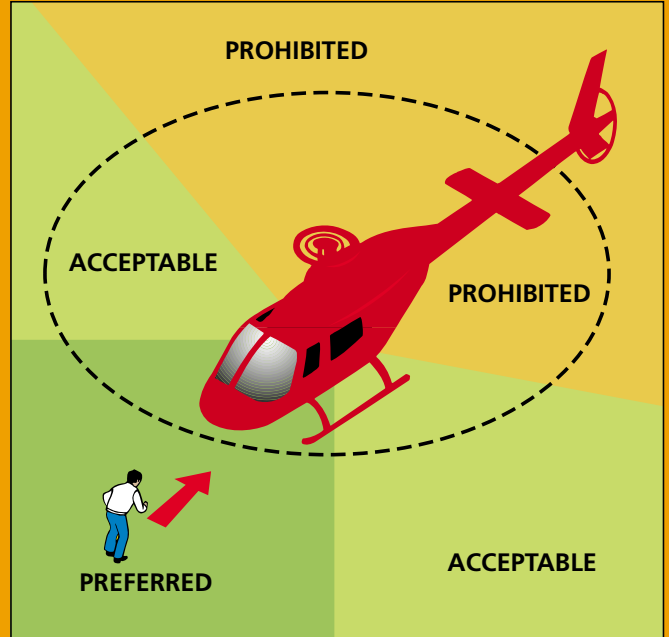
Proceed in a crouching manner for extra rotor clearance. Hold onto hat unless chin straps are used. Never, never, reach up or chase after a hat or other articles that blow away.

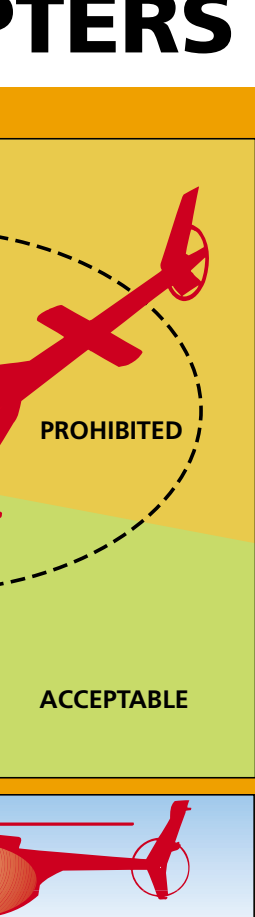
Keep helipad clear of loose articles – water-bags, ground-sheets, tins, etc. Secure other gear from effects of rotor wash.
