# VECTOR

*Pointing to Safer Aviation*

## Maximum Performance

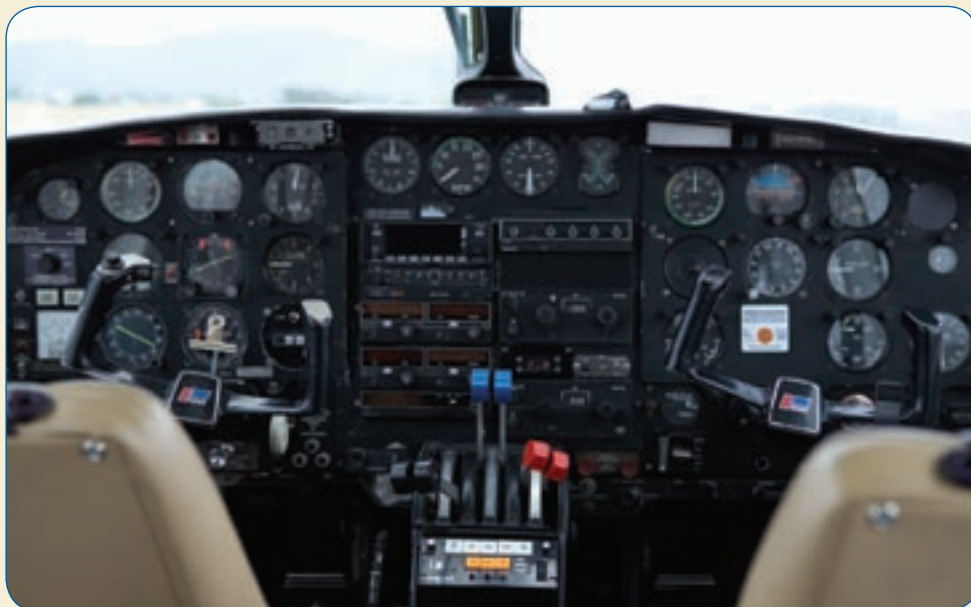
Instrument panel on a PA31-350 Chieftain.

I put the failure of the primary attitude indicator down to the failure of the left engine pneumatic pump to provide enough pressure to spin the instrument's gyroscope. Incidentally, the co-pilot's AI had been overhauled and re-installed the day before the flight.

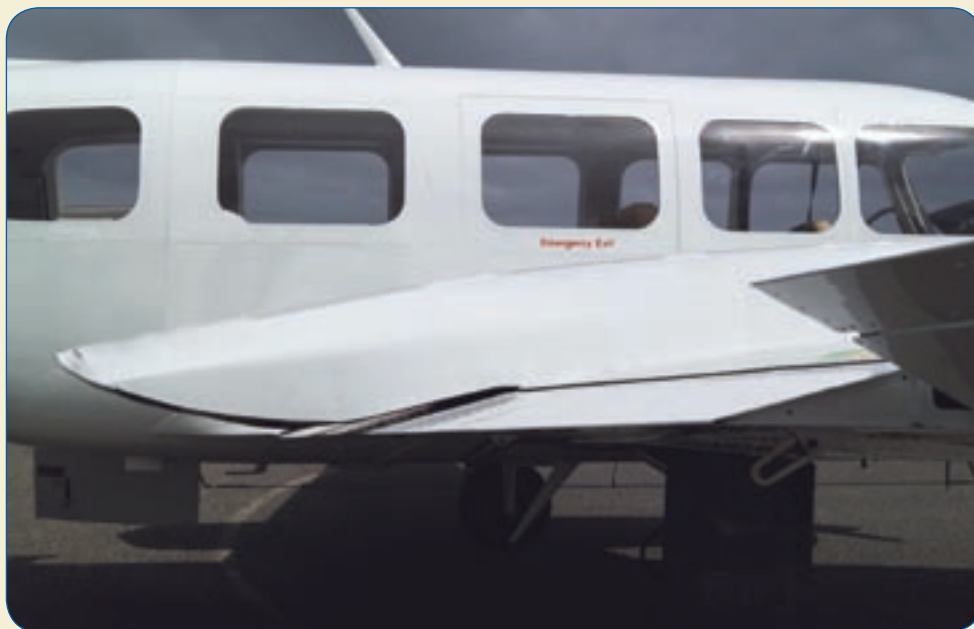
Flap extended 5 degrees.

Meanwhile, I believe I had the aircraft configured for maximum performance and minimum drag, except for the unknown flap problem.

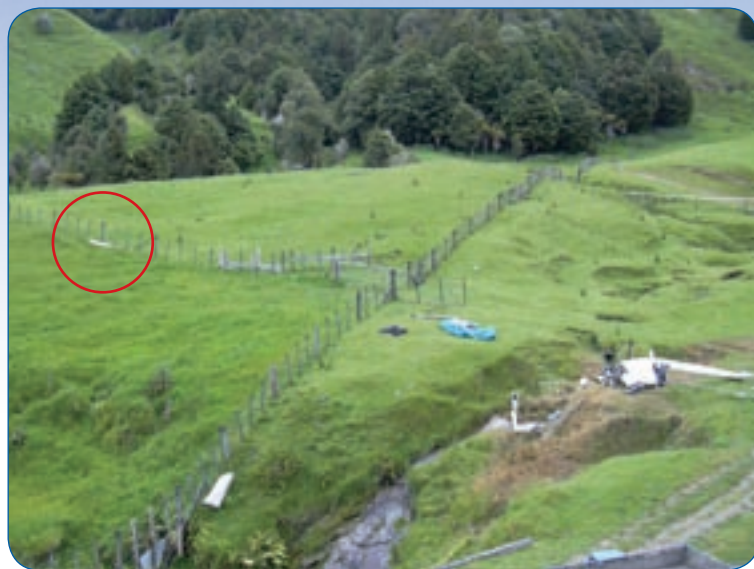
Circle shows the location of the blade after the accident.

The recent and well publicised event, whereby a main rotor blade failed at the root on a Robinson R22 Beta II when the helicopter was only just airborne, is the first reported failure of this type in New Zealand. There have, however, been several instances of failures overseas. These failures are still subject to current investigations by Robinson, the FAA, and in the New Zealand case, CAA of New Zealand.

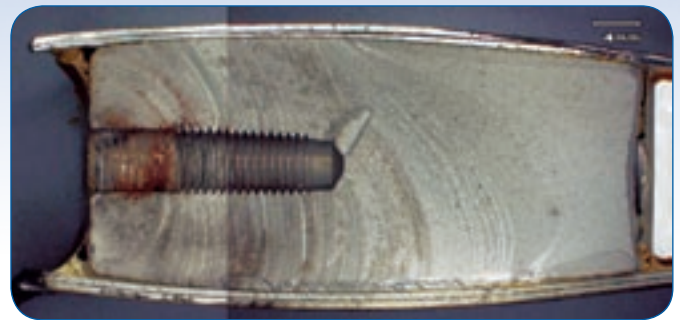
Fracture surface of an R22 blade root, showing fatigue cracking in the root fitting. Note: Growth of fatigue is obscured by external skin and doubler.

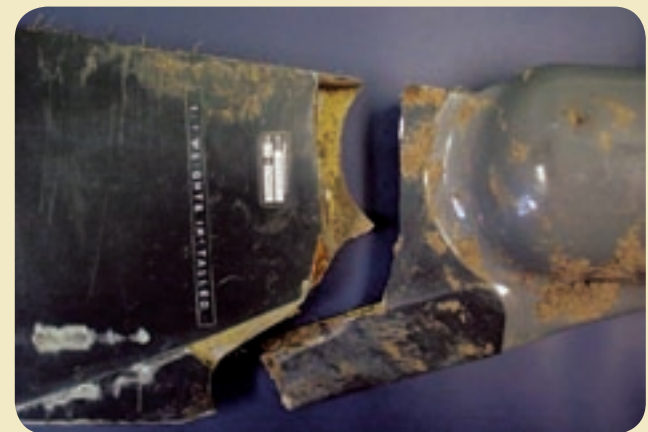
View of fractured blade root.

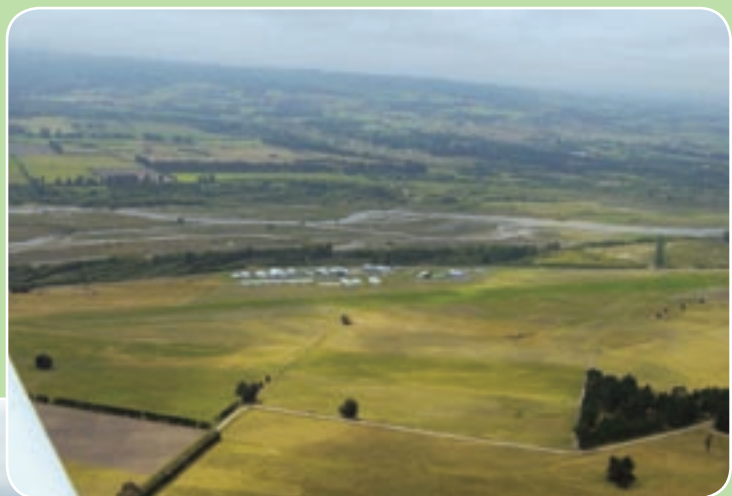
From a distance, the three runways are not easily seen.

The following photos of Rangiora aerodrome illustrate how difficult it can be to spot the location of grass runways. The development of a new (and longer) grass runway 07/25 has meant a much narrower 07/25 runway being used in the interim adding another identification factor.

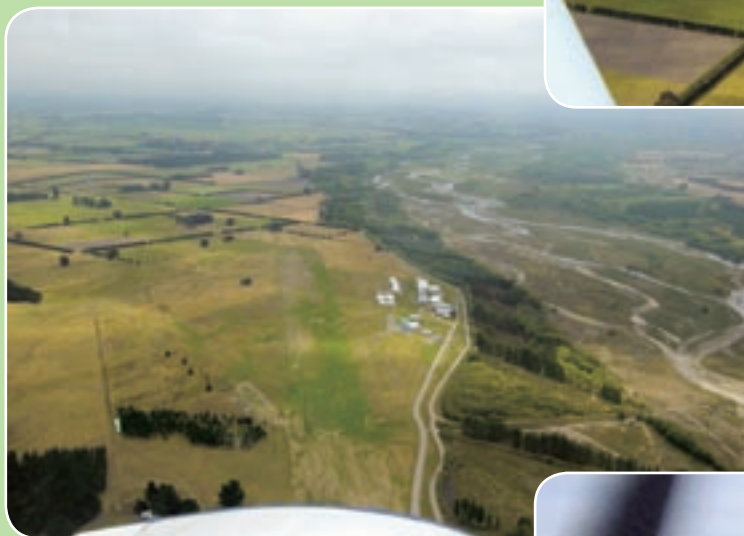
From overhead the airfield, the aerodrome layout is more easily seen, including the white crosses indicating closed areas of the new runway under development beside Runway 07/25. Notice that, if the white crosses were not placed there, then it could be easy to assume that the greener area is the runway.

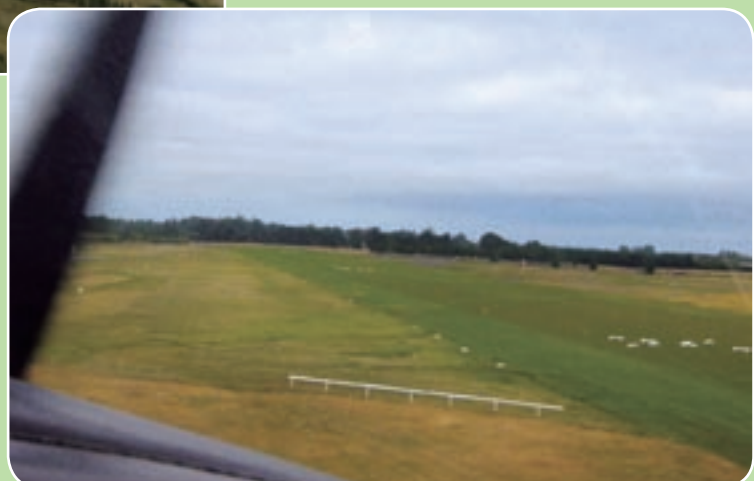
On final approach, notice that the grass runway is marked by painted tyres, and the threshold is marked by a painted fence. The runway area under development is to the right, as indicated by the white crosses.

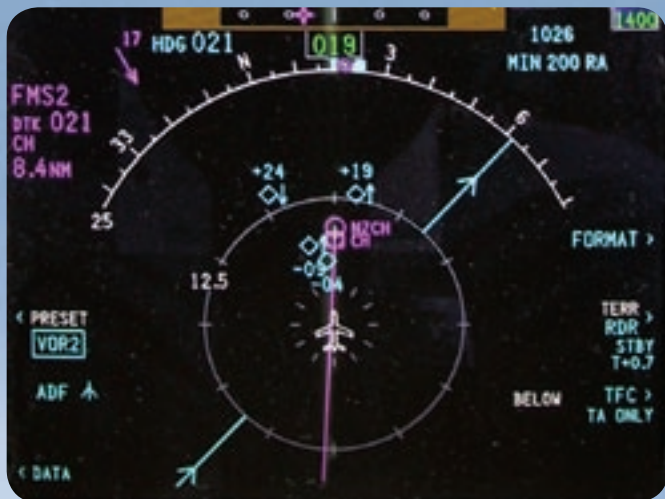
TCAS II display showing targets (blue diamonds).

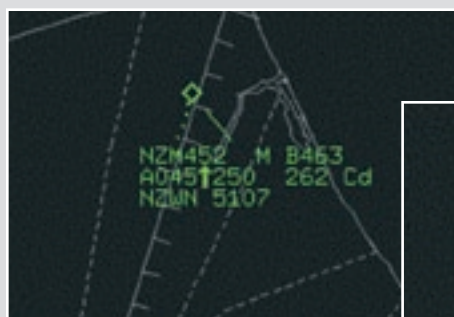
Normal IFR flight

This series of photos show how the screen presentation changes when an emergency code is selected. If a controller selects a target for easier monitoring, a box appears around the target – this box is red when an emergency code is selected.

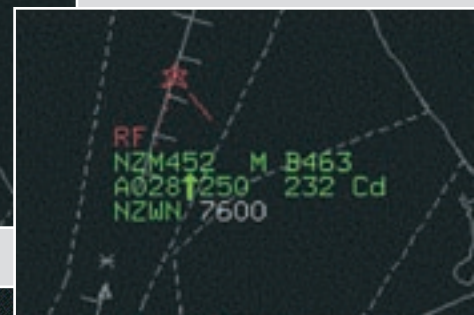
IFR flight squawking 7600 for radio failure

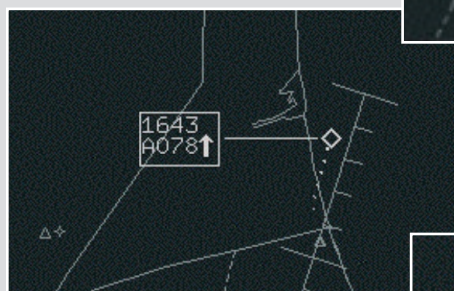
Normal VFR flight on flight plan (selected)

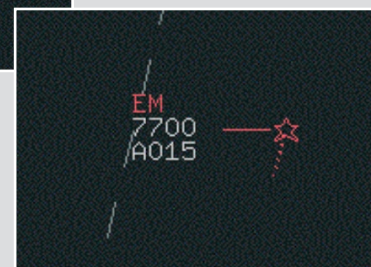
VFR flight squawking 7700 for emergency

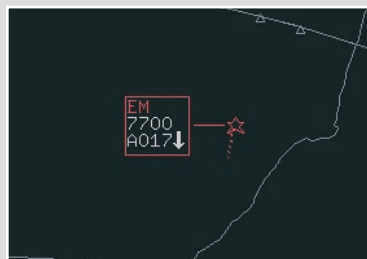
VFR flight squawking 7700 (selected for easier monitoring)
