# VECTOR

## The TWILIGHT ZONE

Hamilton Control Zone –  
New Procedures and Weather Tips  
Helicopter Frost Protection

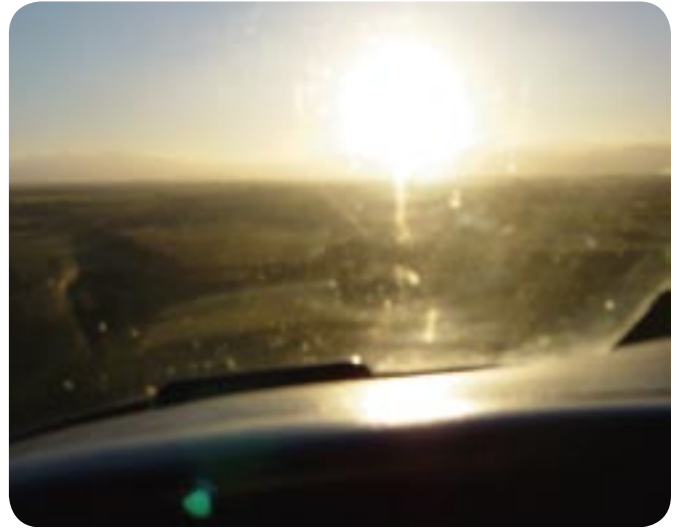
*Sun strike can make it difficult, or impossible (especially if the windscreen is dirty), to judge the approach and landing on a runway which faces into the sun.*

The lower position of the sun can cause sun strike in the early morning and late afternoon. This can make it difficult, or impossible (especially if the windscreen is dirty), to judge the approach and landing on a runway which faces into the sun.

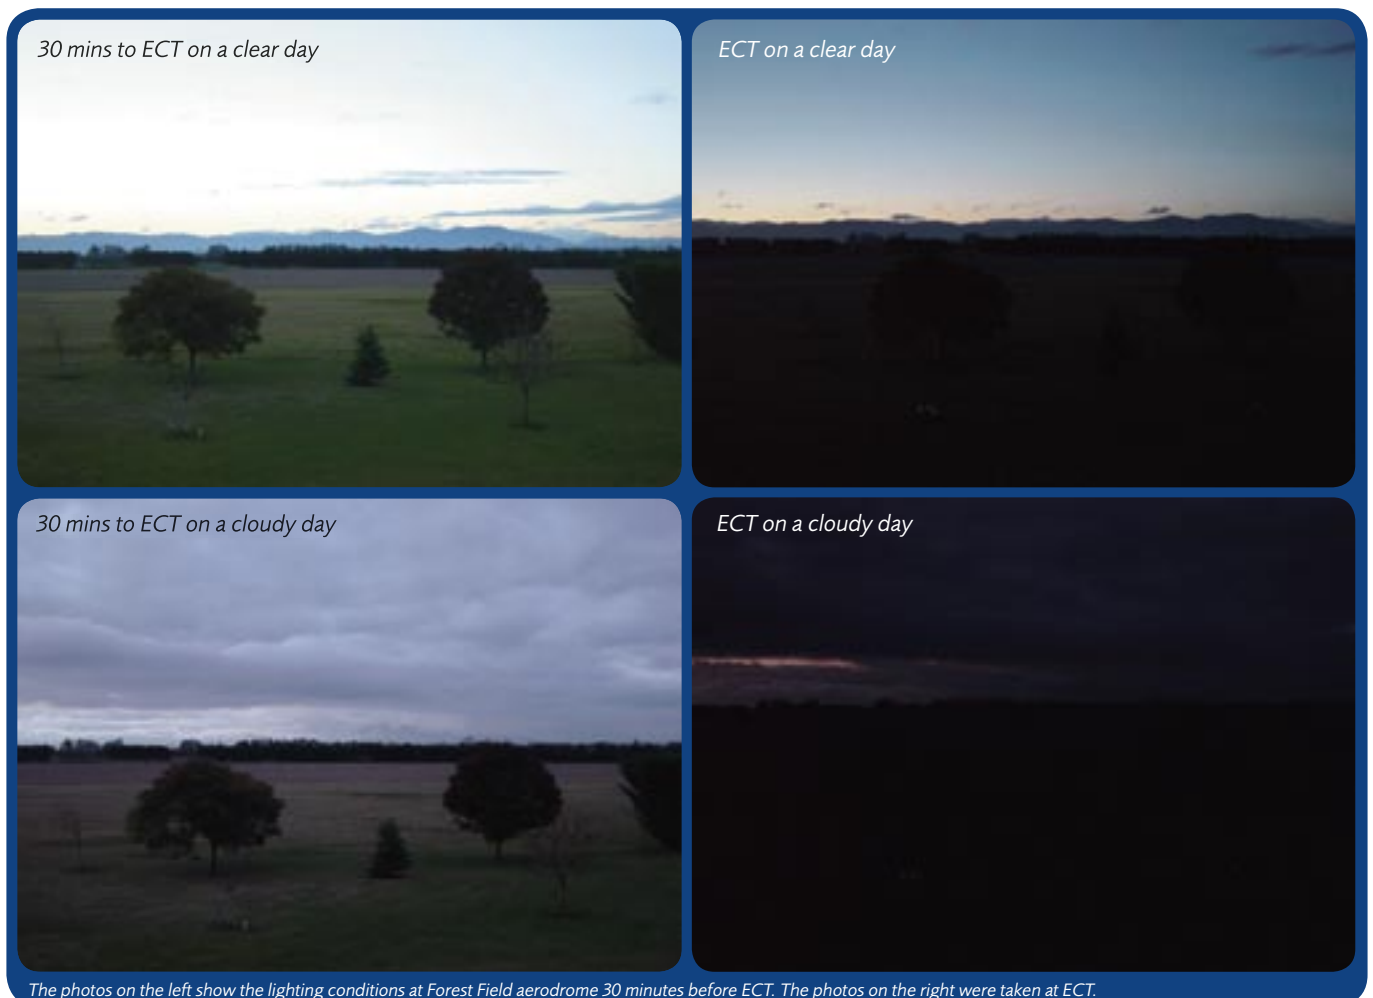
**Figure 3.** Lighting conditions at Forest Field aerodrome during June 2005

*The photos on the left show the lighting conditions at Forest Field aerodrome 30 minutes before ECT. The photos on the right were taken at ECT.*

Cloudy days appear to get darker earlier than clear days. Figure 3 shows the difference in lighting in the late afternoon between a clear day and a cloudy day at Forest Field aerodrome (Canterbury Plains). The photo on the bottom left shows that on a cloudy day it is already beginning to get gloomy. In this situation, if the aerodrome had lighting it could be worthwhile having it switched on to assist you in navigating to the aerodrome.
