VECTOR

POINTING TO SAFER AVIATION

**In, Out
and Around
Taupo**

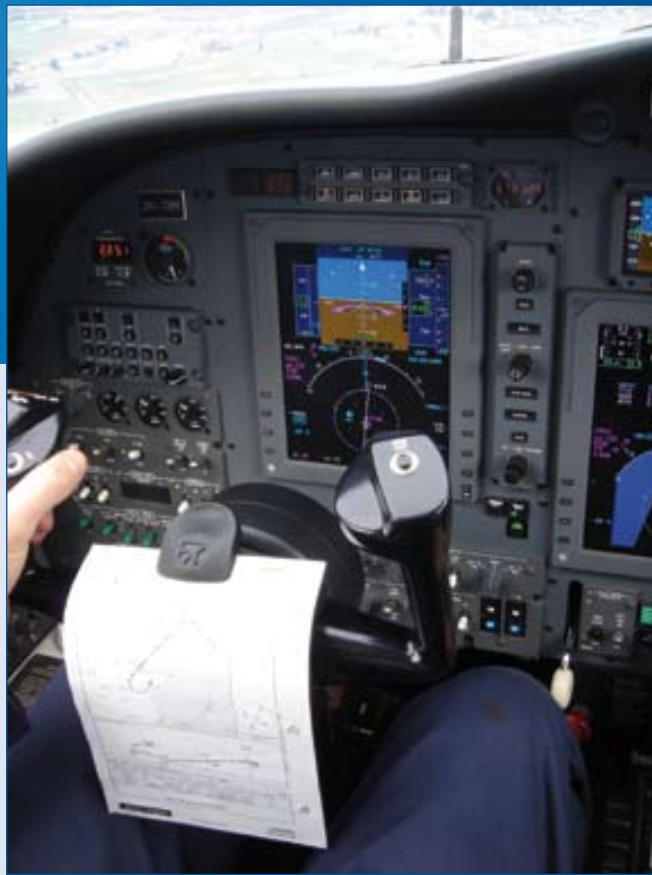
Flying a GNSS approach with vertical path guidance.

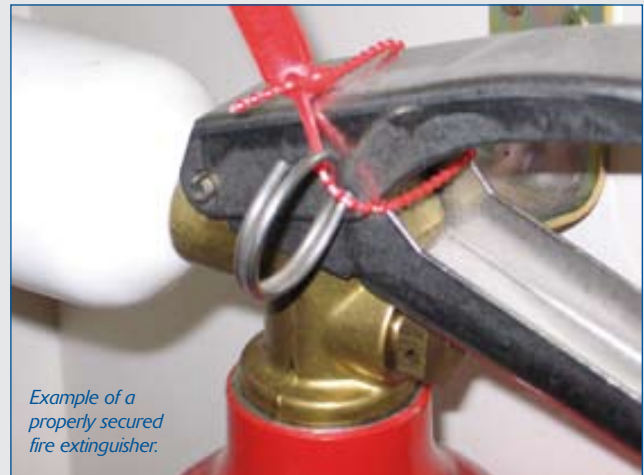
Example of a properly secured fire extinguisher.

The extinguisher was found to have no safety pin fitted and at some stage had been knocked sideways in its supporting bracket, partially depressing the trigger. Had the safety pin been in place, this event would not have occurred. This highlights the importance of including fire extinguishers in pre-flight checks, not only to ensure that safety devices are in position, but also that the extinguisher is fully charged and within its test date.

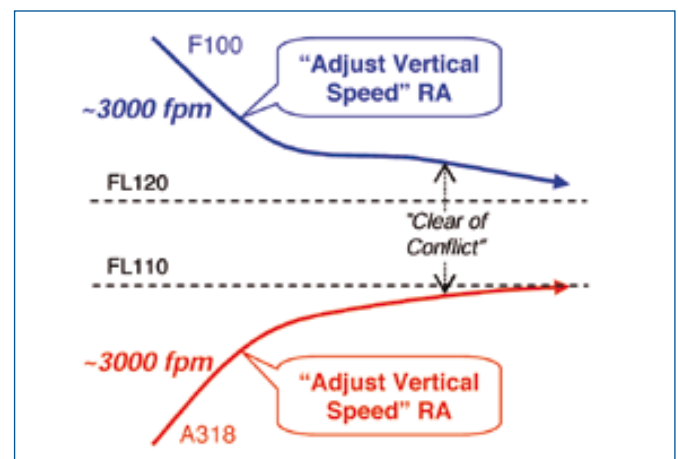
In this European example, an A318 is climbing to FL110 at about 3000 feet per minute. A Fokker 100 is descending to FL120, also at about 3000 feet per minute. The aircraft trajectories are converging both horizontally and vertically. Due to the high vertical closure rate (6000 feet per minute), the A318 and the F100 receive an "Adjust Vertical Speed" RA at respectively 900 and 1000 feet from their cleared flight level. Both advisories request action to reduce the vertical speed to 1000 feet per minute. The A318's rate of climb is reduced to less than 1000 feet per minute. The F100's descent is reduced to about 1000 feet per minute. The correct reactions to the advisories by both pilots minimised the consequences.

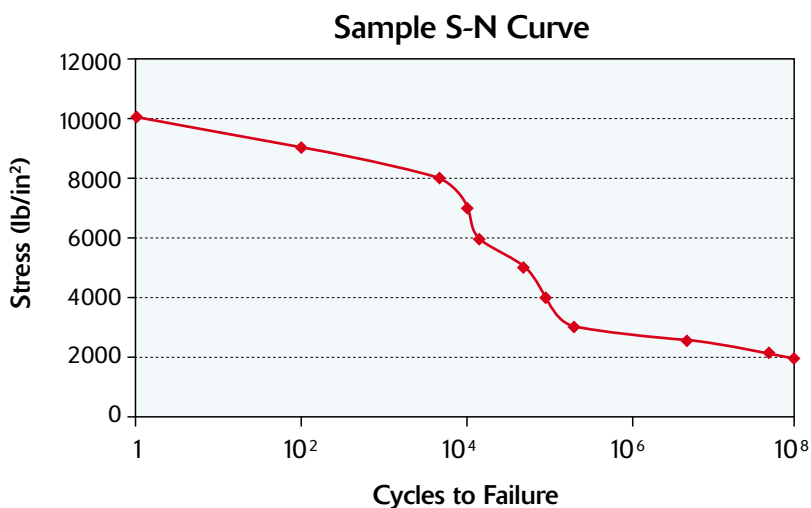
At the lefthand end of the graph we might find that it can withstand 10,000 pounds per square inch (lb/in²), but only once. It can withstand 9999 lb/in² twice, or 9000 lb/in² a hundred times. As we move towards the right, the number of cycles to cause failure increases into the thousands and millions, but the allowable stress per cycle drops lower and lower.

The manufacturer of a new alloy subjects samples of the alloy to extensive testing, and after obtaining a great deal of data, produces an S-N diagram (Stress/Number of cycles). This graph describes how the strength of the alloy varies depending on how many cycles of load are applied. The vertical axis is the stress (load per unit area) applied to the part.

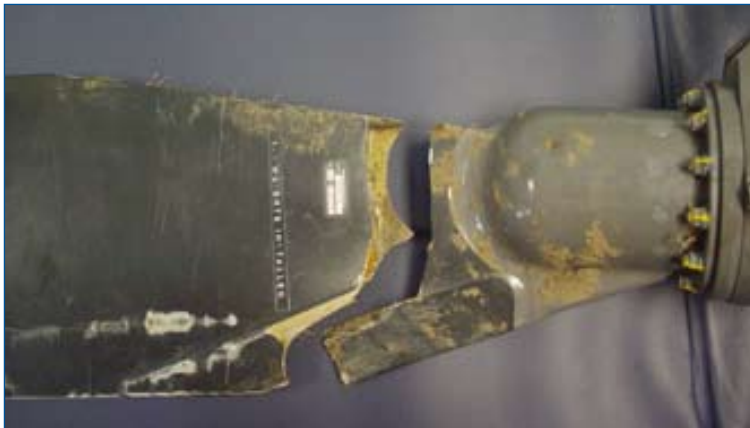
This is a Robinson R22 main rotor blade that failed as a result of metal fatigue. The fatigue striations are clearly evident on the fracture surface. This can occur if the blade is used beyond its design life, or subjected to loads greater than those anticipated by the manufacturer, or a combination of both.

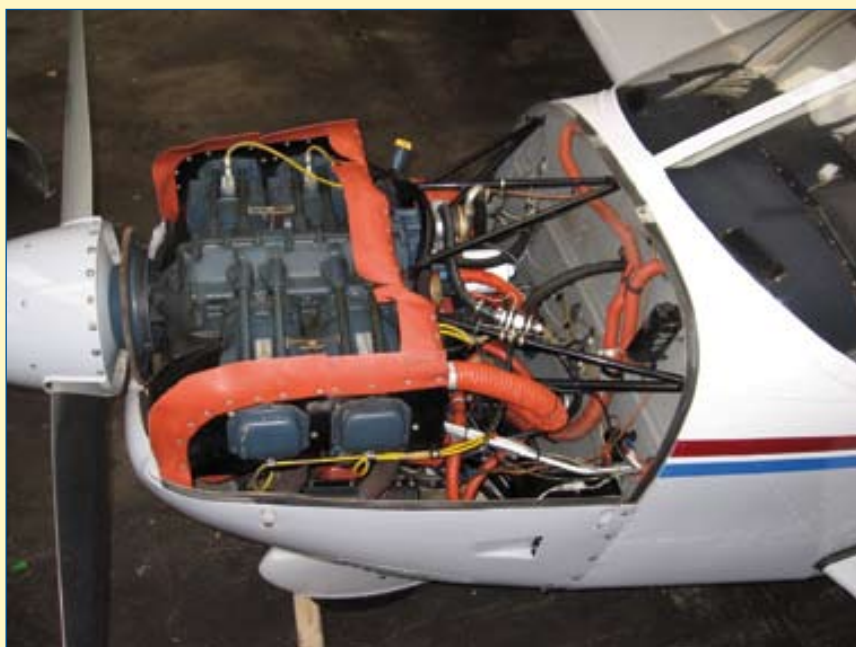
Correctly installed baffle seals in good condition.

When removing cowlings for engine inspection, take a few seconds to check for baffle seal witness marks around what should be the full plenum contact area. The lack of witness

marks is often a clear indication of the seals not doing the job efficiently. Gaps can often be easily spotted by darker coloured streaks where the air has escaped from the plenum area.

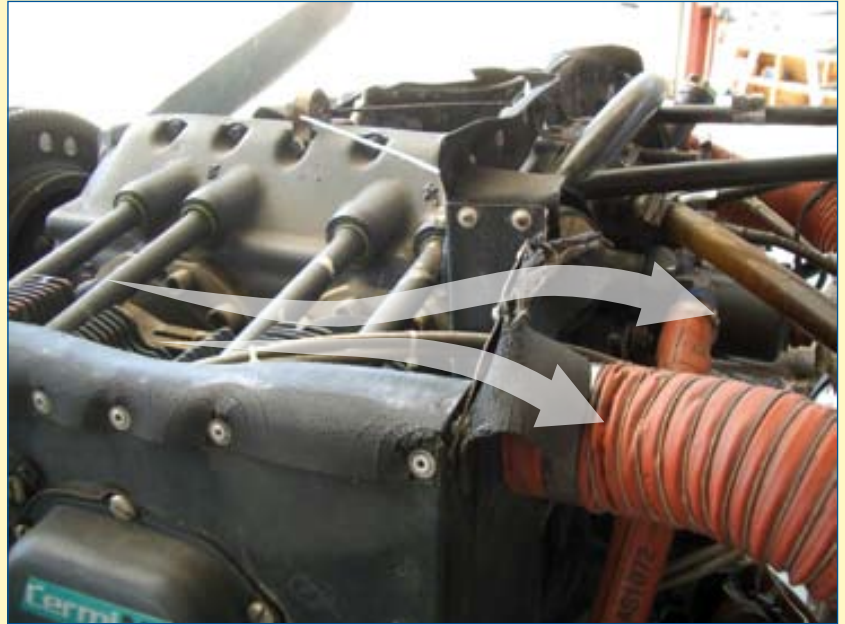
Old, torn and perished baffle seals lead to loss of cold air pressure resulting in engine overheating.

The forward speed of the aircraft converts the effective velocity of the airstream going into the cowl into a 'pressure parcel' of air in the upstream 'cold air plenum' – proper sealing of this is a must. If air is allowed to escape from this plenum, it will not only result in a loss of pressure, and therefore an overall reduction in cooling efficiency, but may also cause localised areas of overheating. Baffle seal deterioration can contribute to such conditions as high cylinder head temperature, high oil temperature/low oil pressure, and valve sticking due to carbon formation in the valve guides.

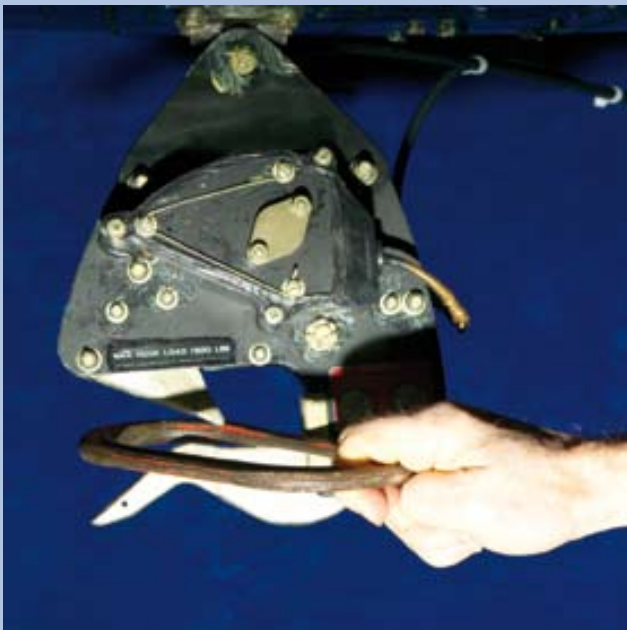
Once the link long axis is above the hook tang, a pull back towards the mouth of the hook will release the spring gate. Goodbye load!
