LITHIUM BATTERY FIRES DO HAPPEN HERE

AvSec officer at Wellington Airport prevents catastrophic event.

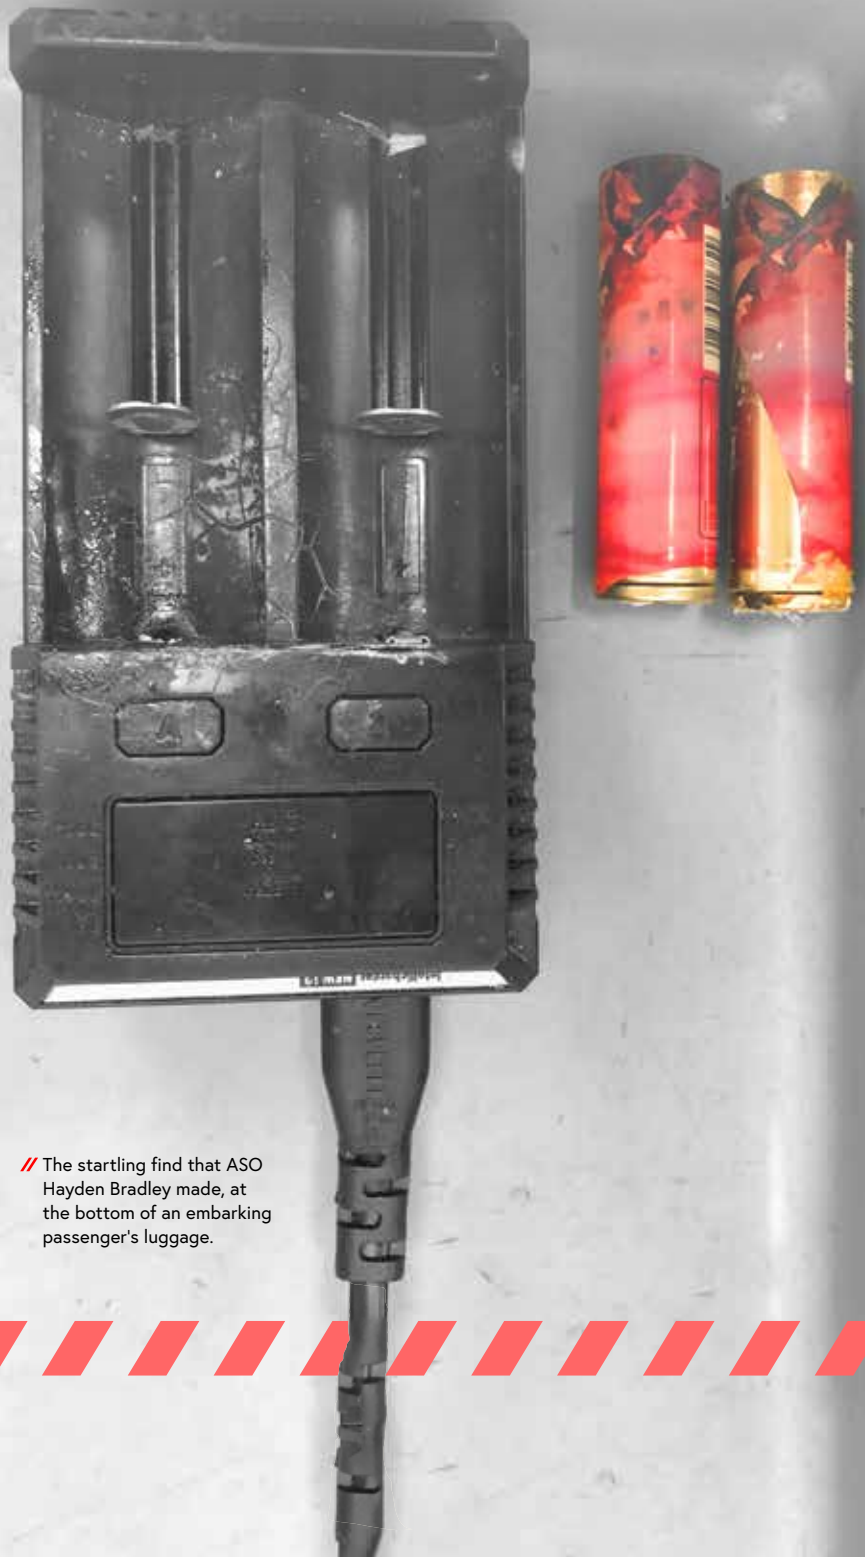
To his astonishment, there was smoke curling out of the bag, and underneath some clothes, he found a very hot and molten vape charger.

"I removed the batteries immediately to prevent further damage and to stop any ignition of the items. They were obviously extremely hot and melted through the PPE gear I was wearing.

// The startling find that ASO Hayden Bradley made, at the bottom of an embarking passenger's luggage.

“The batteries and charger had already deteriorated, and the two components were the ingredients of a catastrophic event.”

Geoffrey says the batteries were in a “volatile state”.

“They contain acid which is corrosive, and the battery charger was still holding energy which would produce heat until all the power was released.

“All this corrosiveness and heat was wrapped in clothing, so the combination was highly flammable.”
